Józef BŁACHNIO  
Mariusz BOGDAN  
Dariusz ZASADA

## INCREASED TEMPERATURE IMPACT ON DURABILITY OF GAS TURBINE BLADES

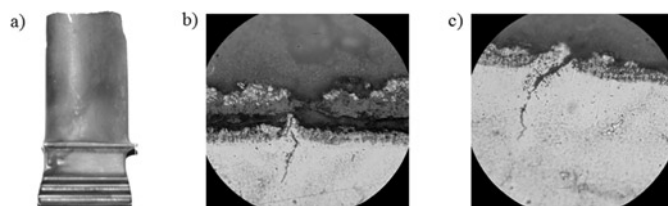
Fig. 1. The example forms of operational failures of an uncooled turbine blade made of the EI 867 type forged super alloy: a) a tip broken due to the super alloy overheating; b) stratification of heat-resistant coatings, and the super alloy crack initiation, x500; c) erosion of the heat-resistant coating and the crack penetrating into the super alloy, x500

The most frequent cases of damage include the overheating of the blades' leaves (Fig. 1a, 2a). It sometimes results in the blade leaf end fracture (Fig. 1a). The destruction process of the gas turbine blade usually begins with the destruction of its heat-resistant coating (Fig. 1b c, 2b).

As a result of it, the blade material is exposed to the direct heat and chemical effect of exhaust gases. This situation mainly causes the material overheating and the formation of the blade leaf cracks (Fig. 1c, 2b). The factors affecting that phenomenon are supercritical temperature, its impact time and chemical aggression of exhaust gases. As an effect of high temperature, and high tensile stresses derived from centrifugation and time, the phenomenon of the blade material thermal expansion occurs. It significantly affects the turbine rotor tip clearance reduction. Consequently, it results in rubbing the blade front against the turbine body (Fig. 2c), which causes additional heating of the blade leaf material and adverse changes in the super alloy microstructure. The changes typical for the high-temperature creeping process with the uniaxial stress state are usually observed in the blades with a plate.

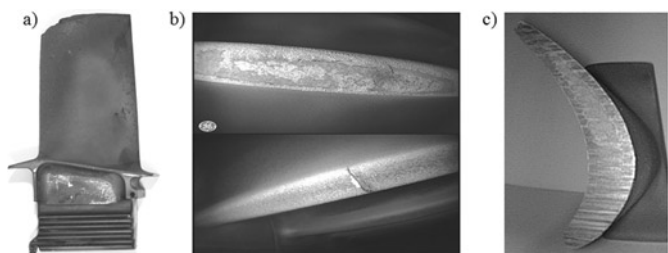
Fig. 2. The example forms of damage of the cooled turbines' blades made of the ZS 32 type cast super alloy: a) the material overheated at the tip [2]; b) complete burning of the coating on the leading edge to expose the super alloy, and a crack on the leading edge [12]; c) blade leaf front chafing [12]

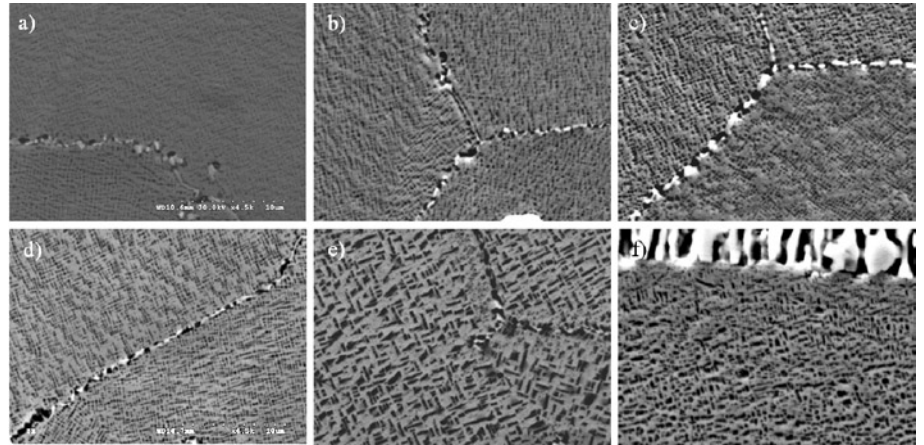
Fig. 5. EI - 867 WD super alloy subsurface microstructure: a) super alloy without heating and super alloy heated for 1 hour at: b) 1023K; c) 1123K; d) 1223K; e) 1323K; f) 1423K (surface x4500)

The initial stage of combining the  $\gamma'$  phase cubic precipitates in plates occurs at the temperature of 1223 K (Fig. 5d). At the temperature of 1323 K, a significant increase and coagulation of precipitates of the  $\gamma'$  reinforcing phase, which takes on the shape of plates, was found (Fig. 5e). The number of precipitates is much smaller, however,

EI – 867 WD alloy is overheated, and the tested blade cannot be considered useful for further operation. The obtained images of a microstructure of the EI - 867 WD alloy subject to the impact of increasingly higher temperature may be a basis for assessing the degree of overheating of the gas turbine blades.

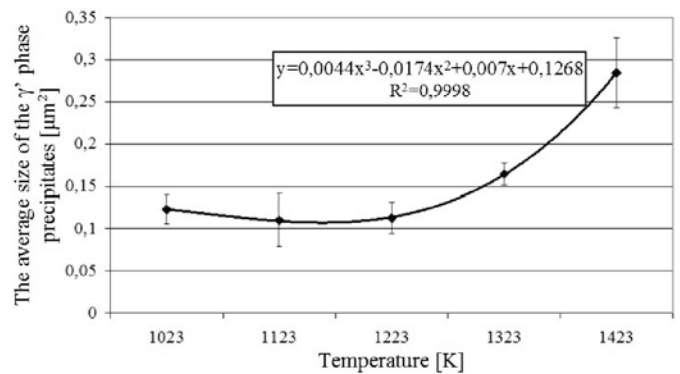
Fig. 6. Changes in the average size of the  $\gamma'$  phase particles in the temperature function

The change in sizes of the  $\gamma'$  phase particles depending on the heating temperature was calculated (Fig. 6). It was found that the initial coagulation stage of precipitates of the  $\gamma'$  reinforcing phase, which is characterised by relatively high regularity and a large number of precipitates per are unit, occurs even at the temperature of 1123 K (Fig. 5b, c). As the temperature rises, the  $\gamma'$  phase structure becomes less regular while increasing the grain size (Fig. 6).

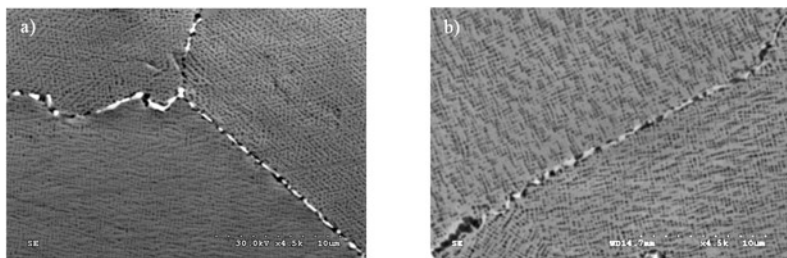
Fig. 3. Morphology of the  $\gamma'$  phase precipitates – heating in the temperature of 1223K for: a) 0.5h; b) 1h (surface x4500)

tion of the size of the  $\gamma'$  dispersion phase (Fig. 3) was obtained. The changes of sizes (surface) of precipitation of the  $\gamma'$  reinforcing phase in the heating time function were determined (Fig. 4).

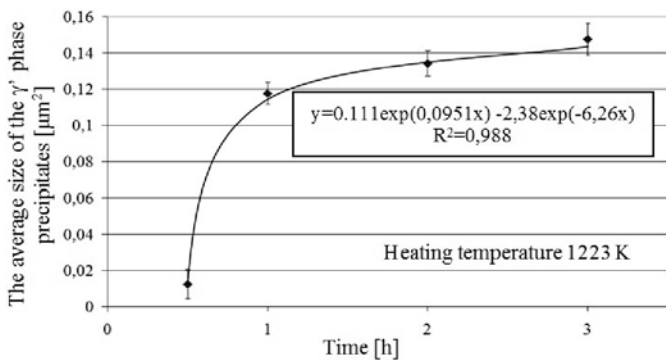
Fig. 4. Changes in the average size of the  $\gamma'$  phase particles depending on the heating time of samples of the blades at the temperature of 1223K

On the basis of Figure 4, the heating time, which was 1h in the research of the impact of high temperatures on the blade material, for a constant temperature, i.e. 1223K, was adopted. At that time, a sudden increase in the size of the  $\gamma'$  phase particles (an additional argument for such a choice is the aircraft task time in the operation conditions for the adopted jet engine type, which is also 1h) occurs.

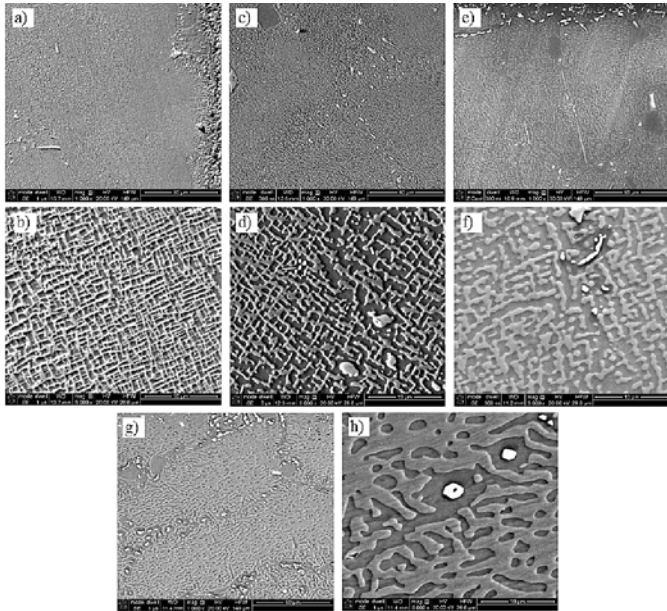
Fig. 7. The increased temperature impact on morphological changes in the cross-section of the leading edge: a, b) new blade No. 1; c, d) blade after the shortest time of operation No. 2; e, f) blade after the average time of operation No. 3; g, h) blade after the longest time of operation No. 4

On the basis of the structural observation conducted with the use of the Quanta 3D FEG scanning electron microscope, a very clear impact of the increased temperature on degradation of the microstructure of the analysed blades made of the ŻS 32 type super alloy was found. The microstructure of the tested blades consists mainly of  $\gamma$  and  $\gamma'$  phases and carbides. It was found that with the operating temperature increase and the time of operation, clear microstructural changes occur (Fig. 7). The significant changes in the morphology of the  $\gamma'$  reinforcing phase were observed. In the blade, the  $\gamma'$  phase new particles ( $\text{Ni}_3\text{Al}$ ) have a cubic shape. As a result of the increased temperature impact, the change of their shape from cubic (Fig. 7a and b) to cuboidal one (Fig. 7c-f) occurs, in order to reach an oval shape at the maximum temperature (Fig. 7g and h).

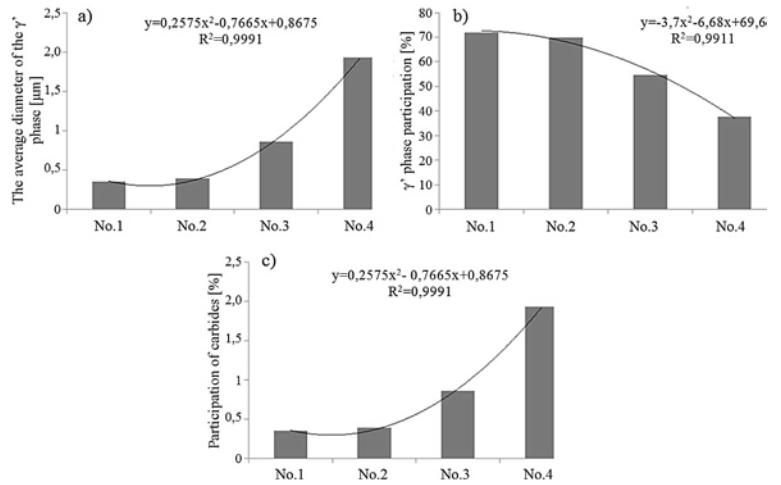
Fig. 8. The increased temperature impact on: a) the average diameter of the  $\gamma'$  phase, b) the  $\gamma'$  phase surface participation, c) surface participation of carbides

The observed changes are related to the expansion of the  $\gamma'$  reinforcing phase and a decrease in its participation (Fig. 8a). In case of a new blade, the average size of the  $\gamma'$  phase particles is approximately  $0.3\mu\text{m}$ . As a result of the impact of increased temperature and operational factors, this value increases to the level of  $2\mu\text{m}$ . The reported trend is also significantly reflected in the surface participation changes of the specified  $\gamma'$  reinforcing phase. It was observed that the surface participation of the  $\gamma'$  phase decreases from 70% for the new blade to 35% for the blade operated at the highest temperature (Fig. 8b). As a result of the increased temperature impact, the observed morphological changes of the  $\gamma'$  reinforcing phase are small, however, its impact on the surface participation of carbides takes place (Fig. 8c).

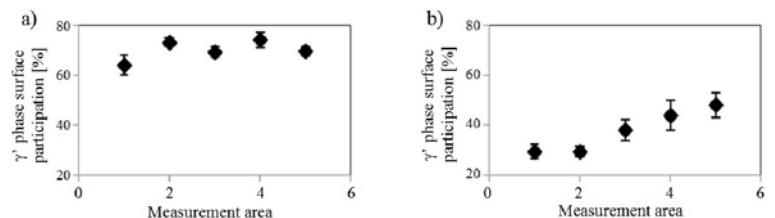
The surface participation of carbides in all the observed blades is at the level of 2-2.5%. Additionally, there were no significant changes in morphology of the observed carbides. However, a clear impact of the increased temperature and operating time of the tested blades on the  $\gamma'$  phase surface participation in particular zones within the cross-section of the tested blades was stated (Fig. 9). In case of the blade exposed to the highest temperature impact and the longest operation time No. 4, while measuring the surface participation of the described phase from the leading edge into the blade, it was found that the surface participation is the lowest (30%). In the distance of this blade, the participation of the described phase rises to the level of about 50%. However, no impact of the observed trend on the size changes of the  $\gamma'$  phase particles was observed in similar areas seen on the cross sections of other blades (Fig. 10).

Fig. 9. Surface participation of the  $\gamma'$  reinforcing phase into the leading edge: a) blade No. 2, b) blade No. 4

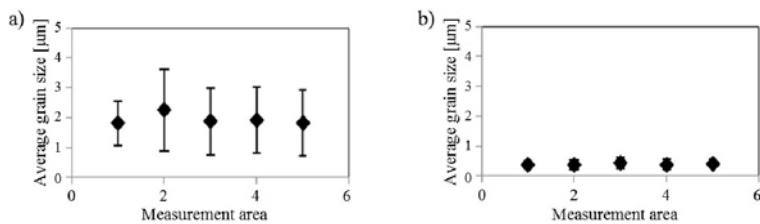
Fig. 10. The average diameter of the  $\gamma'$  reinforcing phase into the leading edge: a) blade No. 2, b) blade No. 4

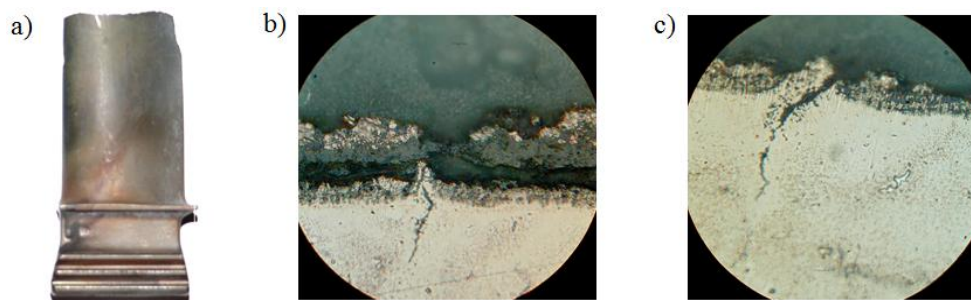
Najczęstszymi przypadkami uszkodzeń są przegrzania piór łopatek (Rys. 1a, 2a). Prowadzi to nieraz do urwania końca pióra (Rys. 1a). Proces destrukcji łopatki turbiny gazowej zwykle rozpoczyna się od niszczenia jej żaroodpornej powłoki (Rys. 1b c, 2b).

Rys. 1. Przykładowe postacie eksploatacyjnych uszkodzeń niechłodzonej łopatki turbiny wykonanej z nadstopu kutego typu EI 867: a) urwany wierzchołek wskutek przegrzania nadstopu; b) rozwarstwienie żaroodpornej powłoki oraz inicjacja pęknięcia nadstopu, x500; c) erozja żaroodpornej powłoki oraz pęknięcie penetrujące w głąb nadstopu, x500

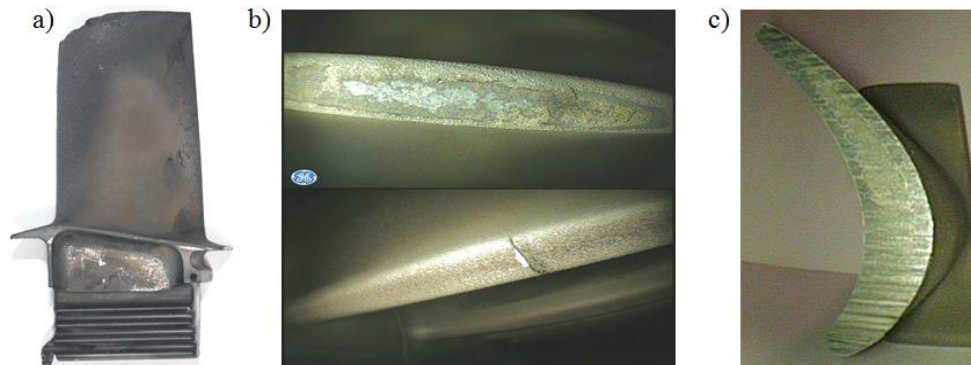
Rys. 2. Przykładowe postacie uszkodzeń chłodzonych łopatek turbin wykonanych z odlewanej nadstopu typu ŻS 32: a) przegrzany materiał przy wierzchołku [2]; b) całkowite wypalenie powłoki na krawędzi natarcia aż do odsłonięcia nadstopu oraz pęknięcie na krawędzi natarcia [12]; c) przytarcie czoła pióra łopatki [12]

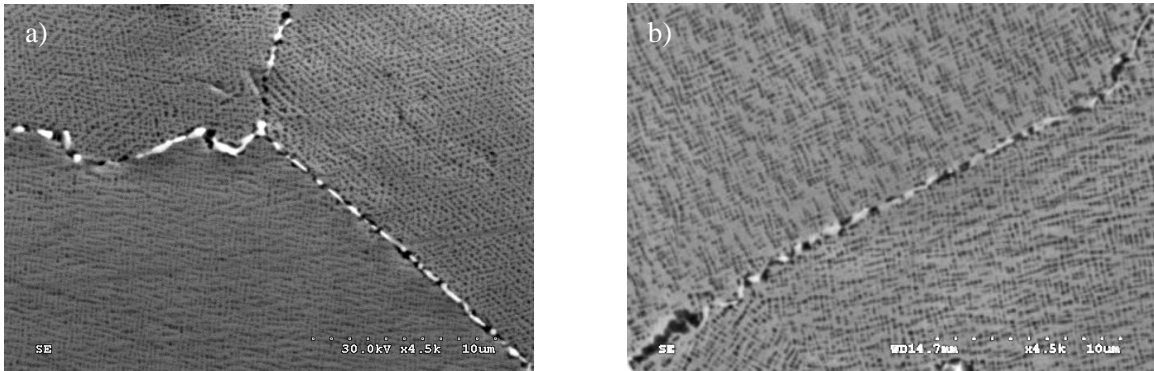
Rys. 3. Morfologia wydzieli fazy  $\gamma'$  - wygrzewanie w temperaturze 1223K przez: a) 0,5h; b) 1h (pow. x4500)

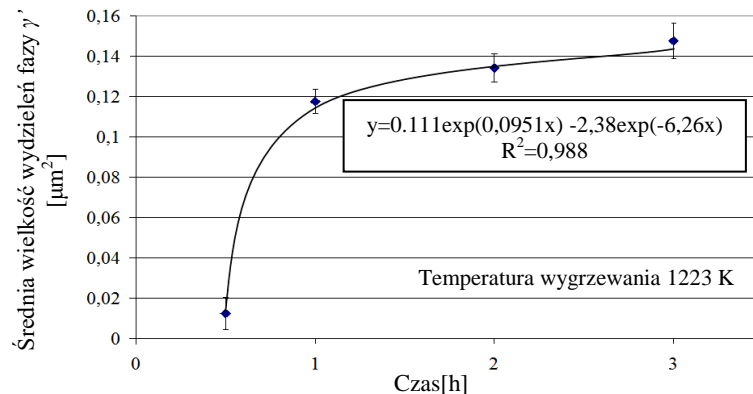
Rys. 4. Zmiany średniej wielkości cząstek fazy  $\gamma'$  w zależności od czasu wygrzewania próbek z łopatek w temperaturze 1223K

Na podstawie rysunku 4 przyjęto czas wygrzewania, który w badaniu oddziaływania wysokich temperatur na materiał łopatek wynosił 1h, dla stałej temperatury, tj. 1223K. W tym czasie następuje gwałtowny wzrost wielkości cząstek fazy  $\gamma'$  (dodatkowym argumentem przemawiającym za takim wyborem jest czas zadania lotniczego w warunkach eksploatacji dla przyjętego typu silnika odrzutowego, wynoszący także około 1h).

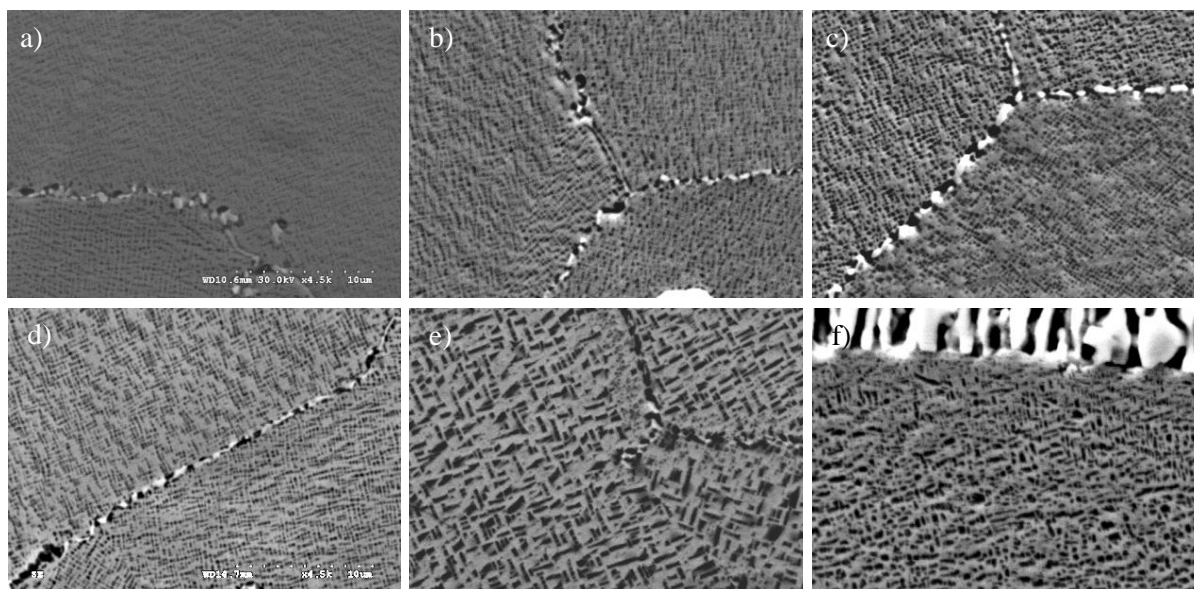
Rys. 5. Mikrostruktura warstwy podpowierzchniowej nadstopu EI – 867 WD: a) nadstop bez wygrzewania oraz nadstop wygrzewany przez 1h w temperaturze: b) 1023K; c) 1123K; d) 1223K; e) 1323K; f) 1423K (pow. x4500)

Początkowe stadium łączenia się sześciennych wydzielen fazy  $\gamma'$  w płytce zachodzi przy temperaturze 1223 K (Rys. 5d). Przy temperaturze 1323 K stwierdzono znaczny już rozrost i koagulację wydzielen umacniającej fazy  $\gamma'$ , która przybiera kształt płytek (Rys. 5e). Mniejsza jest znacznie liczba wydzielen, jednak są one dużo większe niż te, które powstały w temperaturze 1223 K. Morfologia fazy  $\gamma'$  wskazuje, że po przekroczeniu temperatury 1223 K stop EI – 867 WD ulega przegrzaniu.

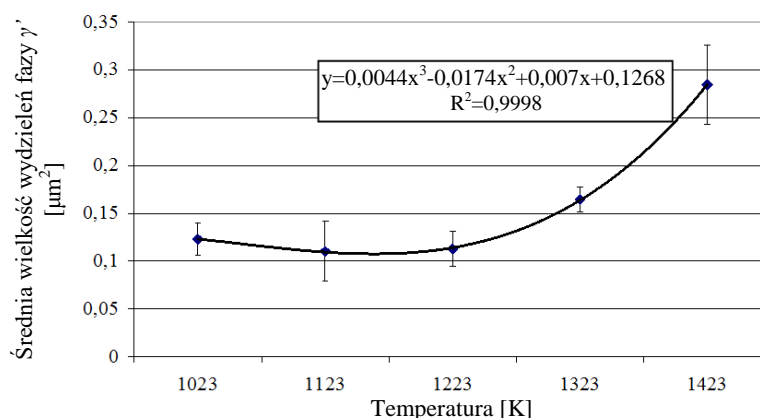
Obliczono zmiany zmianę wielkości cząstek fazy  $\gamma'$  w zależności od temperatury wygrzewania (Rys. 6). Stwierdzono, że już w temperaturze 1123 K powstaje początkowe stadium koagulacji wydzielen umacniającej się fazy  $\gamma'$ , która charakteryzuje się stosunkowo dużą regularnością oraz dużą liczbą wydzielen przypadającą na jednostkę powierzchni (Rys. 5b,c). W miarę wzrostu temperatury struktura fazy  $\gamma'$  staje się mniej regularna przy jednoczesnym wzroście wielkości ziarna (Rys. 6).

Rys. 6. Zmiany średniej wielkości cząstek fazy  $\gamma'$  w funkcji temperatury

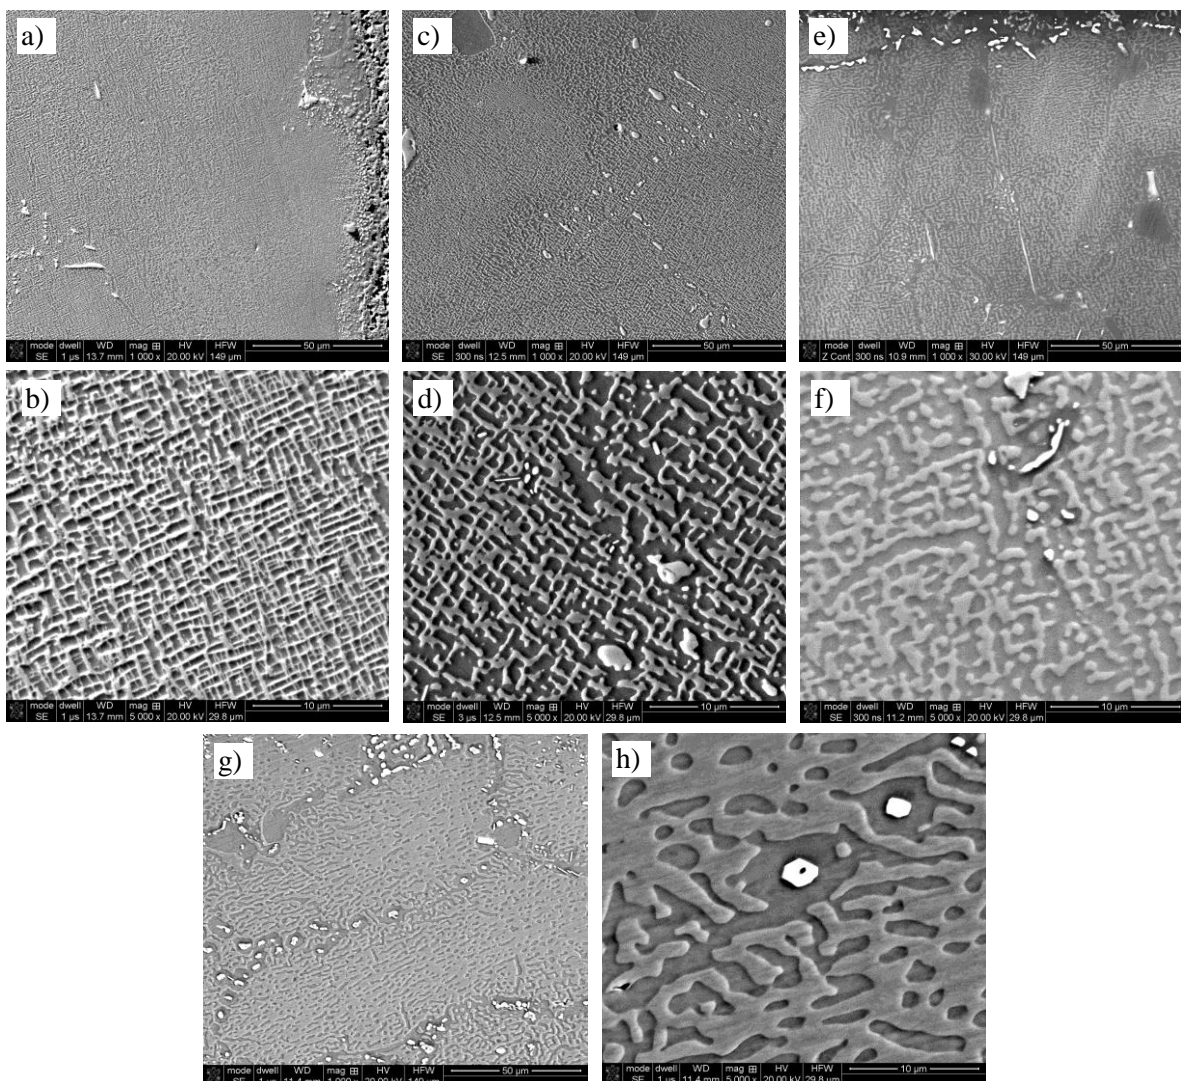
Rys. 7. Wpływ podwyższonej temperatury na zmiany morfologii w przekroju poprzecznym krawędzi natarcia: a, b) łopatka nowa Nr 1; c, d) łopatka po najkrótszym czasie eksploatacji Nr 2; e, f) łopatka po średnim czasie eksploatacji Nr 3; g, h) łopatka po najdłuższym czasie eksploatacji Nr 4

Na podstawie przeprowadzonych obserwacji strukturalnych wykonanych przy użyciu skaningowego mikroskopu elektronowy Quanta 3D FEG stwierdzono, bardzo wyraźny wpływ podwyższonej temperatury na degradację mikrostruktury analizowanych łopatek wykonanych z nadstopu typu ŻS 32. Mikrostruktura badanych łopatek składa się przede wszystkim z fazy  $\gamma$  i  $\gamma'$  oraz węglików. Stwierdzono, że wraz z podwyższeniem temperatury pracy oraz czasu eksploatacji następują wyraźne zmiany mikrostrukturalne (Rys. 7). Zaobserwowano między innymi znaczące zmiany morfologii fazy umacniającej  $\gamma'$ . W łopatie nowej cząsteczki fazy  $\gamma'$  ( $\text{Ni}_3\text{Al}$ ) mają kształt sześcienny (kubiczny). W wyniku oddziaływania podwyższonej temperatury następuje zmiana ich kształtu z kubicznego (Rys.7 a i b) do prostopadłościennego (Rys.7c-f) aby w najwyższej temperaturze przyjąć kształt owalny (Rys.7g i h).

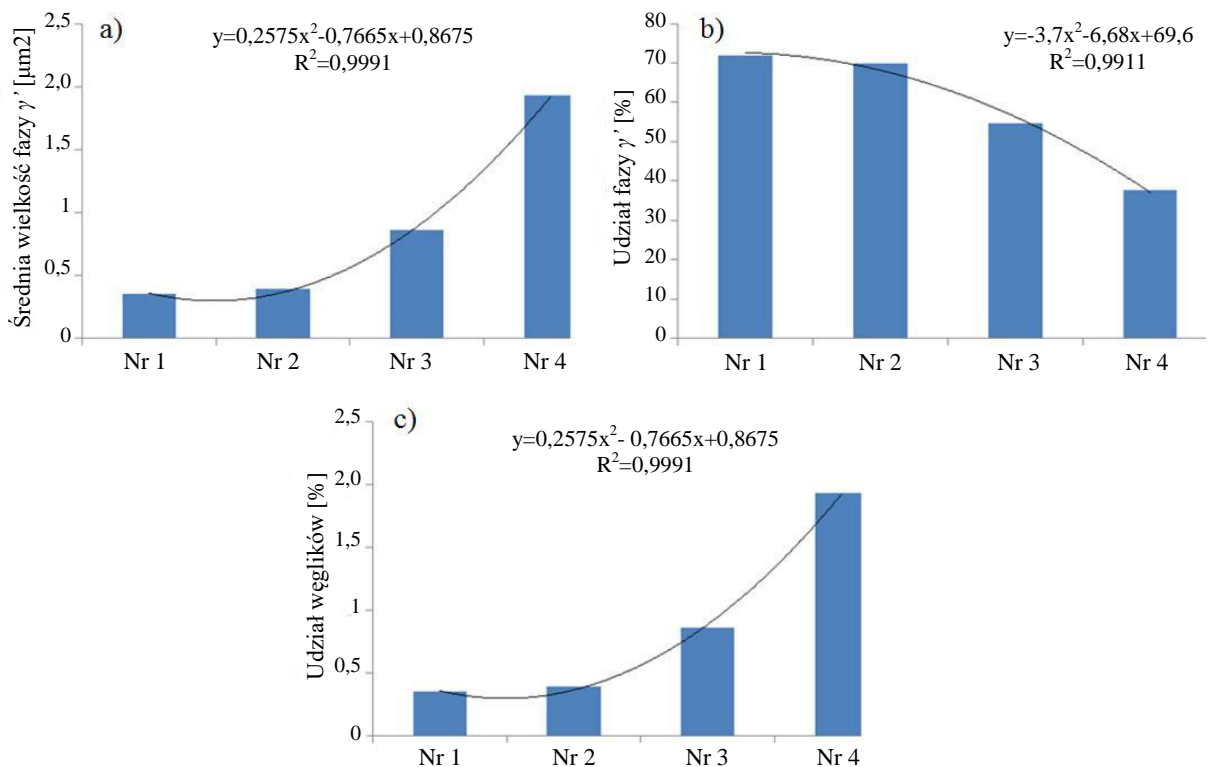
Zaobserwowane zmiany związane są z rozrostem umacniającej fazy  $\gamma'$  oraz spadkiem jej udziału (Rys. 8a). W przypadku łopatki nowej średnia wielkość cząstek fazy  $\gamma'$  wynosi około  $0,3\mu\text{m}$ . W wyniku oddziaływania podwyższonej temperatury oraz czynników eksploatacyjnych wartość ta wzrasta do poziomu  $2\mu\text{m}$ . Odnotowana tendencja ma również znaczące przełożenie na zmiany udziału powierzchniowego opisywanej fazy umacniającej  $\gamma'$ . Zaobserwowano, że udział powierzchniowy fazy  $\gamma'$  zmniejsza się z poziomu 70% dla łopatki nowej do poziomu 35% dla łopatki eksploatowanej w najwyższej temperaturze (Rys. 8b). Zaobserwowane zmiany morfologiczne fazy umacniającej  $\gamma'$  w wyniku oddziaływania podwyższonej temperatury, są niewielkie natomiast występuje jej wpływ na udział powierzchniowy węglików (Rys. 8c).

Rys. 8. Wpływ podwyższonej temperatury na zmiany: a) średniej wielkości fazy  $\gamma'$ , b) udziału powierzchniowego fazy  $\gamma'$ , c) udziału powierzchniowego węglików

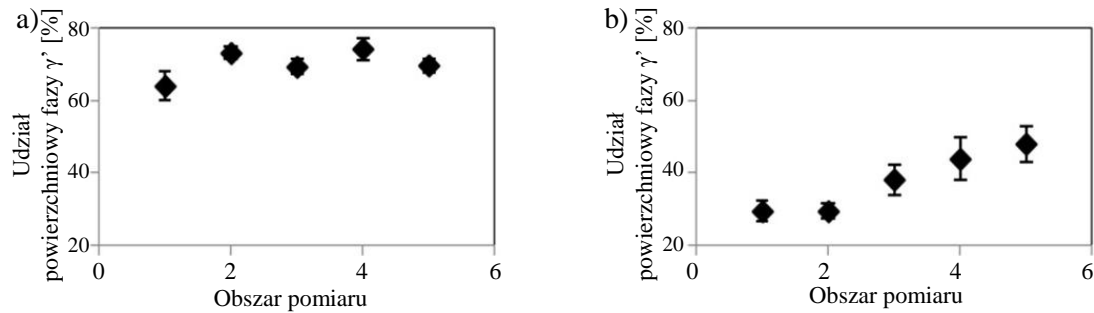
wyraźny wpływ podwyższonej temperatury i czasu eksploatacji badanych łopatek na udział powierzchniowy fazy  $\gamma'$  w poszczególnych strefach na przekroju poprzecznym badanych łopatek (Rys. 9). W przypadku łopatki narażonej na oddziaływanie najwyższej temperatury i najdłuższego czasu eksploatacji Nr 4, stwierdzono, mierząc udział powierzchniowy opisywanej fazy od krawędzi natarcia w głąb łopatki, że przy samej powierzchni jest on najmniejszy (30%). W głębi tej łopatki udział opisywanej fazy wzrasta do poziomu około 50%. Nie zaobserwowano natomiast wpływu stwierdzonej tendencji na zmiany wielkości cząstek fazy  $\gamma'$ , w analogicznych obszarach obserwowanych na przekrojach poprzecznych pozostałych łopatek (Rys. 10).

Rys. 9. Udział powierzchniowy umacniającej fazy  $\gamma'$  w głąb krawędzi natarcia: a) łopatka Nr 2, b) łopatka Nr 4

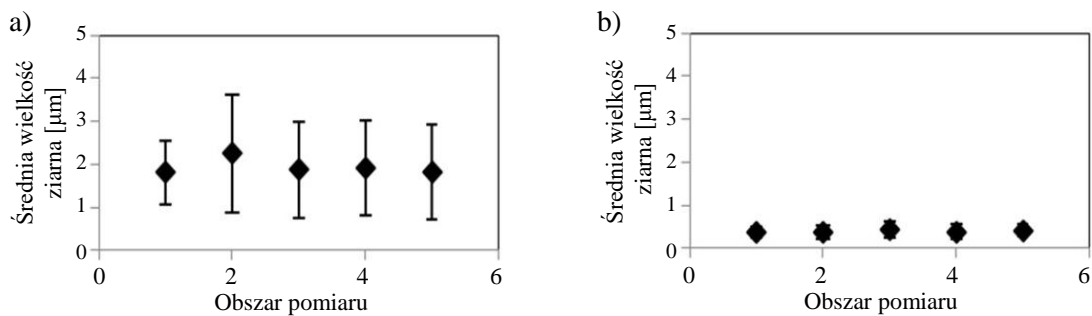
Rys. 10. Wielkość ziaren umacniającej fazy  $\gamma'$  w głąb krawędzi natarcia: a) łopatka Nr 2, b) łopatka Nr 4
