## **Operational Problems of Selected Elements of the Dobrzyca Barrage on the Głomia River**

*Mateusz Hämmerring, Natalia Walczak,  
Tomasz Kałuża, Anna Oliskiewicz-Krzywicka  
Poznan University of Life Sciences*

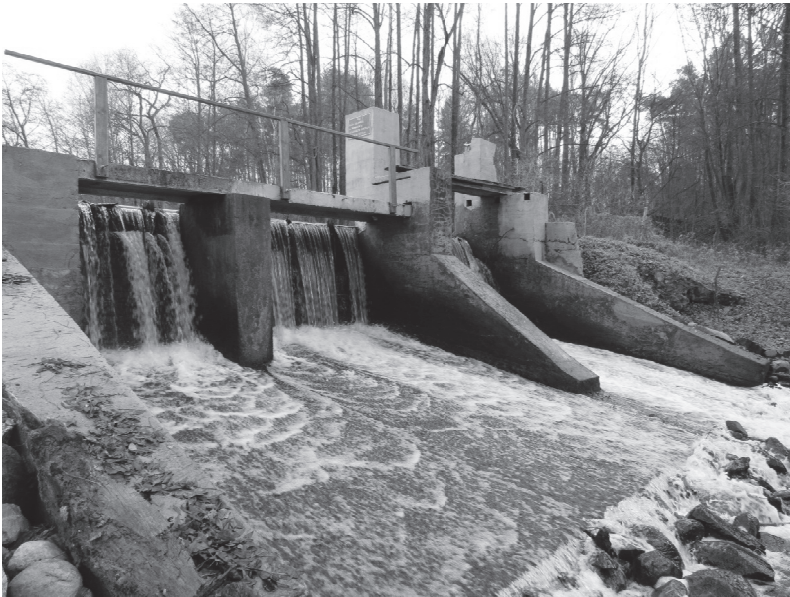
**Fig. 2.** View on the weir in Dobrzyca on the Głomia river

The results of the technical condition assessment of individual elements of the barrage are presented in Table 1. The condition of the weir is unsatisfactory. There are no hoisting devices that serve to operate shutters. Footbridges are equipped only with temporary wooden railings (the structure lacks railings from the upstream side). Additionally, there is no fixed footbridge for the gate no. 3. The ordinates of piers, abutments and footbridges do not meet safety recommendations for the existing impoundment on the weir. There are observed some damaged reinforcements in the downstream. Though, riprap near the end sill is visible only at a length of approx. 1m. The structure is subject to systematic maintenance work, however, some damage to the abutment (concrete defects) are found on the right bank, as well as there are some soaks on the impoundment wall and concrete cracks in the structure near the gate no. 3. The data collected both on the basis of direct observations (WI) – 2.13 as well as an analysis based on photographic documentation (WII) – 2.25 have given an overall unsatisfactory rating.

Due to the fact that the weir in Dobrzyca on the Głomia river is not equipped with hoisting devices for wooden shutters, the author have taken a rating of 0 for calculating an average assessment value. It indicates that movable elements are in an unacceptable condition. The low technical assessment of the weir is also resulted in the condition of its concrete structure.

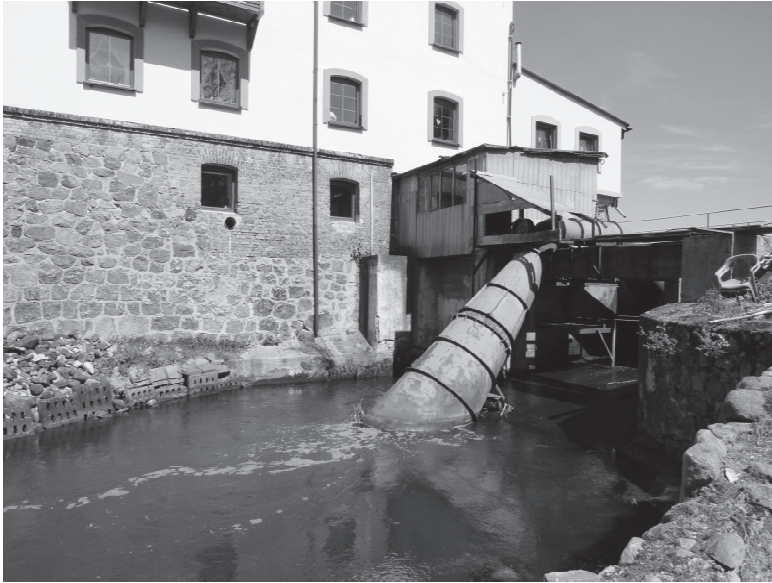
**Fig. 4.** Downstream view of SHPP at the Dobrzyca barrage on the Głomia river  
**Rys. 4.** Widok na dolną wodę MEW na stopniu Dobrzyca na rzece Głomi

What is more, the power plant is also in an unsatisfactory technical condition. A provisional shed roofed with corrugated plate requires significant repair works. Reinforcements from the downstream side also require replenishment, especially on the right bank at the corner of the building. There is no possibility of manoeuvring with an idle discharge at the power plant – it has been permanently closed with stop logs. There is no water gauge in the downstream part. According to method WI, an average rating of 2.94 has been obtained, and according to WII – 2.75, indicating its unsatisfactory condition.

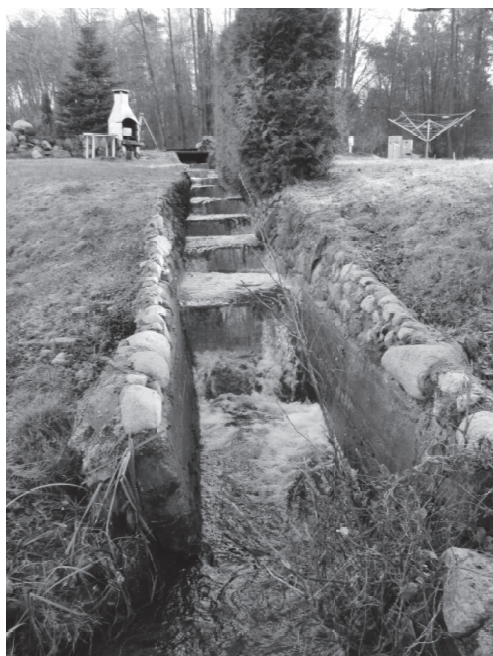
An important element of the barrage is its pool fish pass, consisting of 9 pools of length from 1.2 m to 1.85 m and an average width of 1.0 m (Fig. 5). The fish pass is 0.15 m thick and its pools fish pass are approx. 0.4 m. deep. Measurements carried out during field tests have proven a poor technical condition of the fish pass and its overall malfunction.

**Fig. 5.** Pool fish pass by Dobrzyca barrage on the Głomia river  
**Rys. 5.** Przeławka komorowa stopnia Dobrzyca na rzece Głomi

The fish pass has been rebuilt recently, however on the basis of Tymiński et al. 2017 and FAO/DVWK 2002 it was found that condition and potential for fish migration are still unsatisfactory. The entrance to the fish pass from the upstream side is very narrow. Currently, the fish pass has been remodelled as a pool fish pass (incl. chambers), except for there is no bottom opening in walls of pool fish pass overflows. Therefore, the fish pass operates as a cascade, with water flowing over upper openings (Fig. 5). In addition, the last pool fish pass is located approx. 10m from the end of the fish pass, and a difference in water levels between the last poolfish pass and the downstream is approx. 40 cm. From the downstream side the fish pass lacks several last pools fish pass (overflows). Its exit is incorrectly situated, since the last section is directed at the right angles to the outlet from the power plant. The system also does not provide reinforcements at the final section, the right bank of the fish pass. The fish pass entrance from the downstream side is very shallow approx. 20 cm. According to method WI the fish pass has been given an average rating of 2.53, whilst according to WII – 2.40, what indicates an unsatisfactory condition of the structure.
