**Stanisław GUZOWSKI\***, **Maciej MICHNEJ\***, **Grzegorz ZAJĄC\***

## **TRIBOLOGICAL WEAR OF WHEEL RIMS IN RAIL VEHICLES IN OPERATING CONDITIONS**

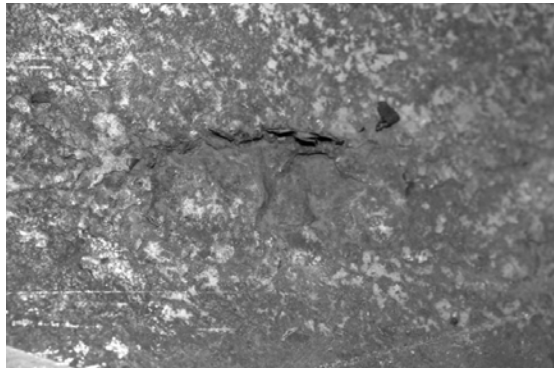
It must be stressed that the macro-image of the wheel wear on the wheel thread aroused serious doubts in the sense of its proper cooperation with the rail, which was systematically removed during frequent forcing of re-profiling of the wheel outer profile due to wheel rim undercut. Macroscopic observations of the wheel thread of the wheel sets showed that there are various damages and wear on the wheels. The most characteristic ones are damages in the form of cracks and fatigue chippings on the wheel thread (shelling, spalling) (**Fig. 2**)

**Fig. 2. Damage of the wheel – cracks and fatigue chippings [L. 2]**

Rys. 2. Uszkodzenia na powierzchni tocznej koła – pęknięcia i wykruszenia zmęczeniowe [L. 2]

Inadequate strength properties and hardness found for the wheel rims are favourable for an excessive abrasive and plastic wear of the rims and wheel threads. Fatigue cracks and chippings on the wheel surface result from flat spots and thermal cracks formed during momentary heating of the wheel due to friction between the wheel and the rail.

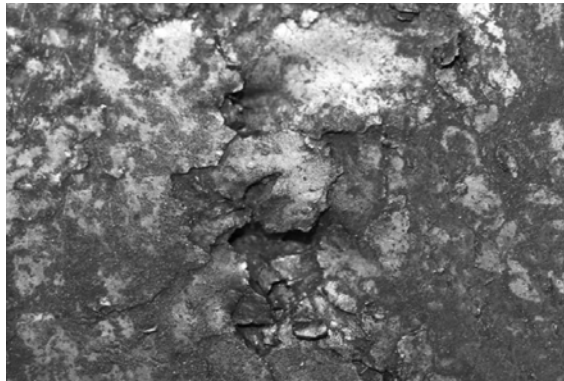
and the material delamination of the wheel thread in the form of shells followed by their rolling (**Fig. 3**).

**Fig. 3. Damage of the wheel – delamination [L. 2]**

Rys. 3. Uszkodzenia na powierzchni tocznej koła – rozwarstwienia materiału w postaci łusek i ich rozwalcowanie [L. 2]

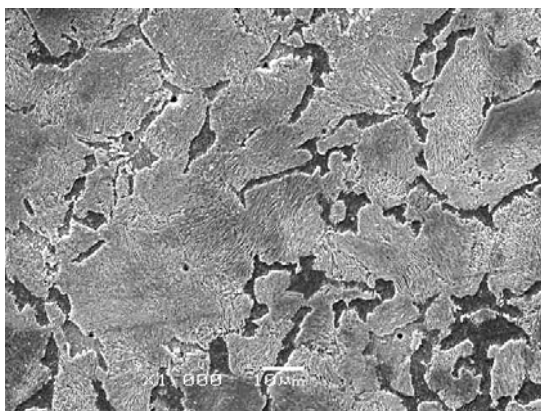
**Fig. 4. Examples of typical microstructure [L. 2]**

Rys. 4. Przykłady typowej mikrostruktury perlityczno-ferrytycznej w wieńcu koła monoblokowego [L. 2]

Steel microstructure tests were carried out using a scanning electron microscope. They showed that the used grade of steel has pearlite microstructure and behind the limits of pearlite grains there is a ferrite network. The structure of pearlite is lamellar and the average dimension of a pearlite grain is within 30–40  $\mu\text{m}$ . On the basis of detailed microscopic observations, it can be inferred that the wheel was not subjected to hardening process + tempering, because, in the surface layer, there was no steel microstructure characteristic of thermal treatment process in the form of martensite or bainite (after hardening), neither were there any tempering microstructures.

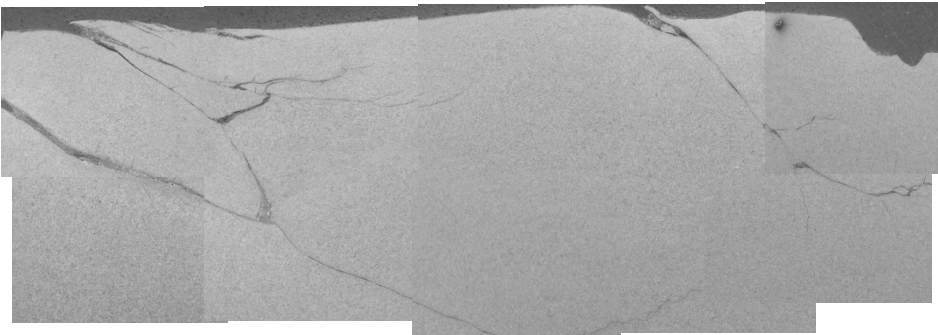
**Fig. 5. Grid of macro-cracks in the surface layer of the wheel rim [L. 2]**

Rys. 5. Siatka makropęknięć w warstwie wierzchniej wieńca koła monoblokowego [L. 2]

Fractographic tests of the samples from the wheel rim proved the existence of numerous exploitation macro cracks on the wheel thread in the form of tears of a characteristic shape of elongated tongues and shells. As it can be seen from the microphotographs, the formed cracks are partly filled with corrosion products.

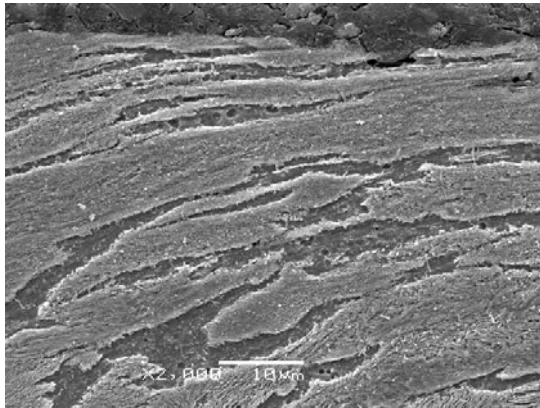
**Fig. 6. Plastic deformation of the surface layer of the wheel rim [L. 2]**

Rys. 6. Znaczne odkształcenie plastyczne mikrostruktury perlityczno-ferrytycznej warstwy wierzchniej wieńca koła [L. 2]

In all the microphotographs taken in the surface layer of the wheel rims, traces of considerable plastic deformations can be observed. Plastic tears are the result of cooperation processes between the wheels and the rails during braking. On the track surface, tear nuclei are formed in the shape of elongated tongues oriented towards the friction force activity. Insufficient strength properties and hardness of the tested wheels are favourable for this phenomenon. These tears in the form of fissures with sharp tops are the cause of the propagation of fatigue cracks that may reach depth exceeding several millimetres. A change in the direction of the rotation of the exploited wheels and intensive braking is especially favourable for this phenomenon.

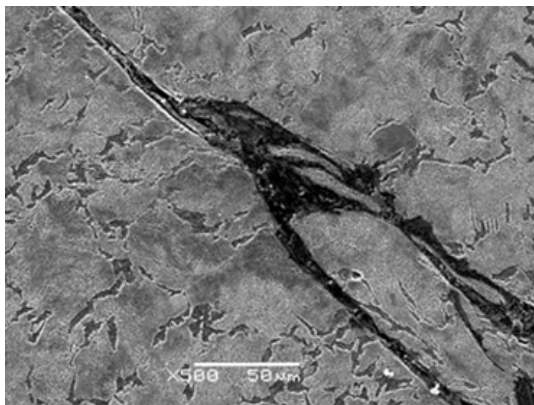
**Fig. 7. Example of cracking in the rim of the wheel [L. 2]**

Rys. 7. Przykład toru pęknięcia w wieńcu koła [L. 2]

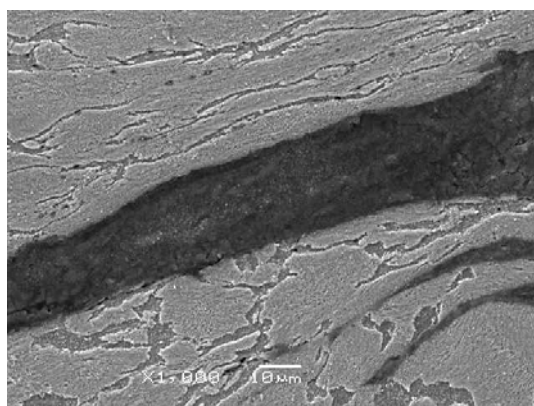
**Fig. 8. Plastic deformations of steel microstructure in the area of cracking [L. 2]**

Rys. 8. Plastikne odkształcenia mikrostruktury stali w obszarze toru pęknięcia [L. 2]

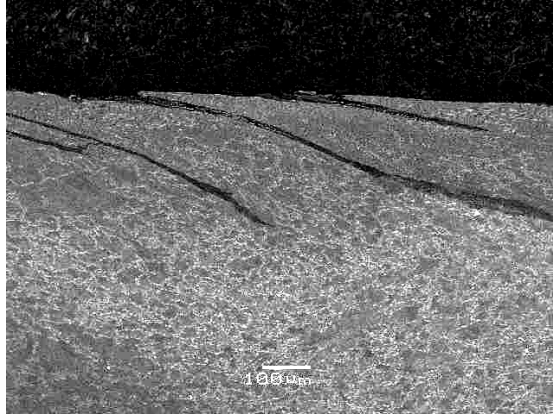
**Fig. 9. Macro cracks on the surface with significant plastic deformation microstructure [L. 2]**

Rys. 9. Makropęknięcia na powierzchni tocznej wieńca koła ze znacznymi odkształceniami plastycznymi mikrostruktury perlityczno-ferrytycznej [L. 2]
