## Evaluation of Modern Diesel Engine Fuel Injectors

Tomasz Osipowicz, Sebastian Kowalek

Experimental research concerned diagnose of electromagnetic Bosch Common Rail injector with catalog number 0445110083. The aim of researches was to make correct diagnose and eventually regeneration process of the researched injector. Researches were made by using special instruments and testing machines in a laboratory research unit and then repairing injection systems of combustion engines.

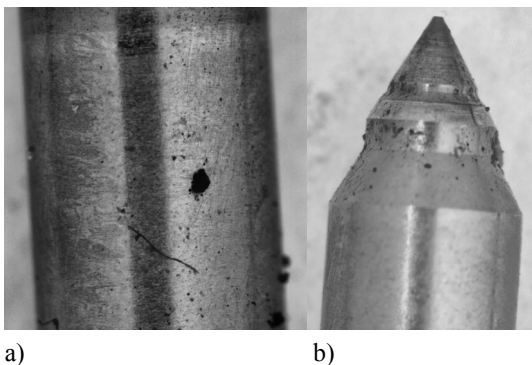
Fig. 4a. Element of injector precision vapour, b) Injector nozzle needle

Experimental researches were made according to the following procedure: the injector was disassembled into spare parts and subjected to verification by using stereoscope microscope. Picture 4 shows elements of needle precision vapour which open and close at fuel spraying. There are visible marks of intensive wear of the vapour stream nozzle in picture 4a. It is easy to notice little marks of corrosion in picture 4b but it has no influence on nozzle work [20]. As it can be visible in the picture, the needle is a little bit dirty with wastes coming from fuel. There are no marks of metal filings.

The analysis of the carried out diagnose shows that researched fuel injector retained its own work parameters. The pictures made during microscope researches showed elements of steering valve and precision vapour after short use. Theoretically, these spare parts should be replaced with new ones, judging from the pictures. But tightness dosages and discharges tests showed that in spite of cavity wear of spare parts, the injector has all the working parameters correct. It means that it can be recognized as capable of good operation. Worrying is the fact of appearance of metal filings on valve surface steering in the injection work picture 5a. It means that the whole injection system should be disassembled, cleaned and dismantled and the height of pressure pump checked because metal filings come from it.

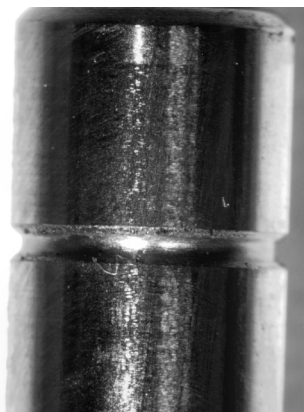
Fig. 5. Piston precision vapour steering valve of fuel injector

There is the element of piston steering injector valve precision vapour in picture 5. The dark surface means intensive use of precision vapour element. It has influence on the amount of fuel discharge.

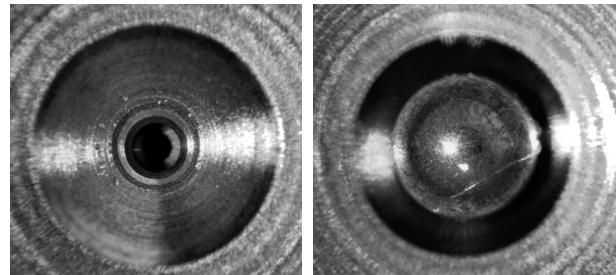
Fig. 6. Steering valve of Common Rail Bosch injector – left without a ball, right with a ball

Picture 6 presents a section of steering valve electromagnetic Common Rail Bosch injector. It shows the section without a ball in picture 6a and the section with a ball in picture 6b. Steering valve is in good condition. Picture 6b shows the steering valve with the ball – as it is visible the ball fits well to the section, which has a huge influence on good fuel injection work.

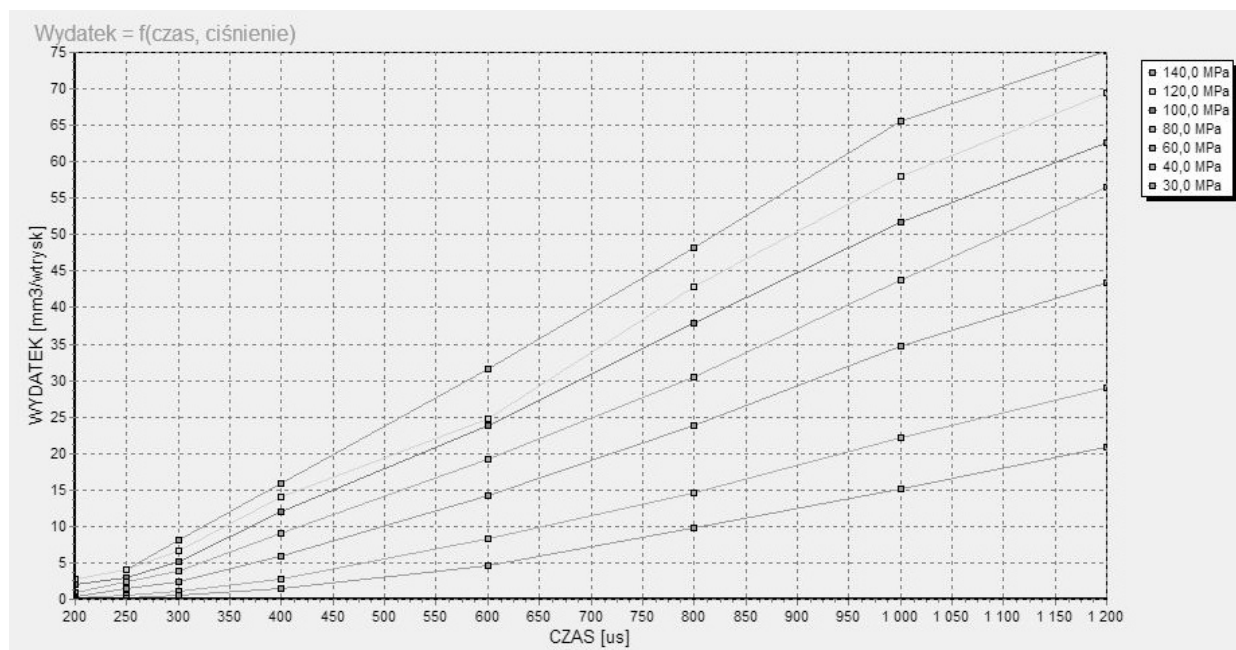
Fig. 7. Characteristic of the researched injector on testing machine

at various pressures and injection times. The characteristics is useful because it can be compared to all injectors in the engine in the whole range of work. Beginning from micro dosages and ending on full load with maximum injection times and pressures. Picture 7 presents full research on Bosch fuel injector characteristic with catalog number 0445110083.
