Dominika GRYGIER

## THE IMPACT OF OPERATION OF ELASTOMERIC TRACK CHAINS ON THE SELECTED PROPERTIES OF THE STEEL CORD WIRES

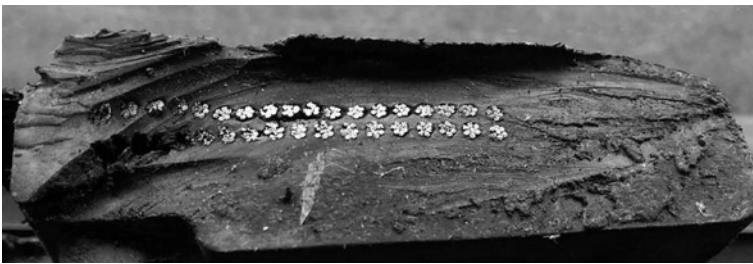
Fig. 4. Schematic diagram of the steel cord shown in Fig. 3, visible seven strands of 0,9 mm in diameter

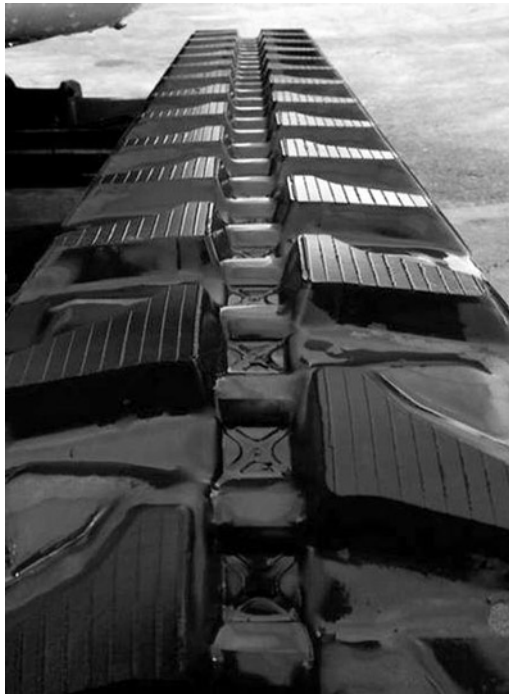
Fig. 6. The elastomeric track No. 1, the non-operated specimen. There are no cracks and damages at its surface, the tread edges are sharp and the segment walls are uniform. Visible remnants of the production process in the form of linear shoulders

The macroscopic tests of the track No. 1 have shown that the contact surface of the track with foundation was ideally flat and the remnants of the production process were observed at surface of the tread in the form of linear shoulders (Fig. 6). Edges of the tread of the tested track were ended sharply and walls of the segments were uniform. Material of which the tested component was made was uniform and did not show symptoms of ageing and thickness of the tread was about 47 mm.

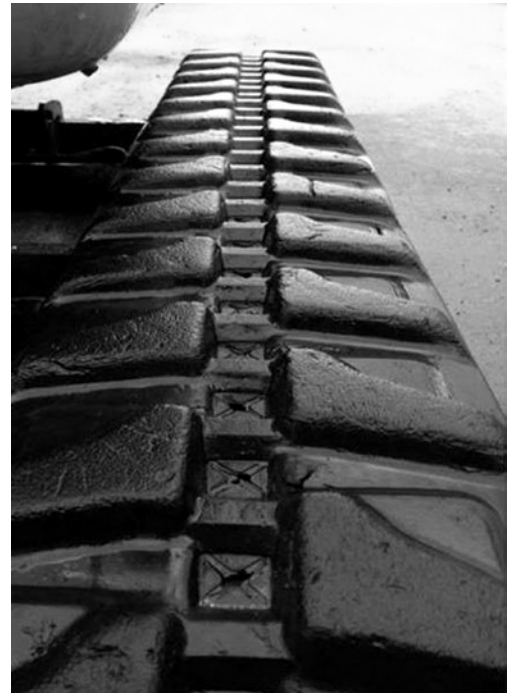
Fig. 7. The elastomeric track No. 2, the specimen in the after-operating state through the period of 1228 working hours. Numerous cracks and damages visible at the surface, the tread edges are significantly rounded and the tread is porous

The macroscopic tests of the track No. 2, in the after-operating condition have shown that it bears significant traces of wear resulting from utilizing of the machine. At its working surface many changes and damages resulting from direct contact with hard basement have been observed (Fig. 7). Edges of the tread were significantly rounded, which influences the decreased traction of the machine during maneuvering in the slushy terrain. Another trace of operating were losses in the form of ripped pieces of rubber as well as cuts and undercuts

of the tread. The most important, and at the same time the most dangerous, symptom of the track wear were visible transverse cracks created as a result of maneuvering the vehicle around its own axis at the hard, e.g. concrete or asphalt surface. The surface of the tested track was porous and borne the traces of rubber ageing, its thickness amounted to about 40 mm.

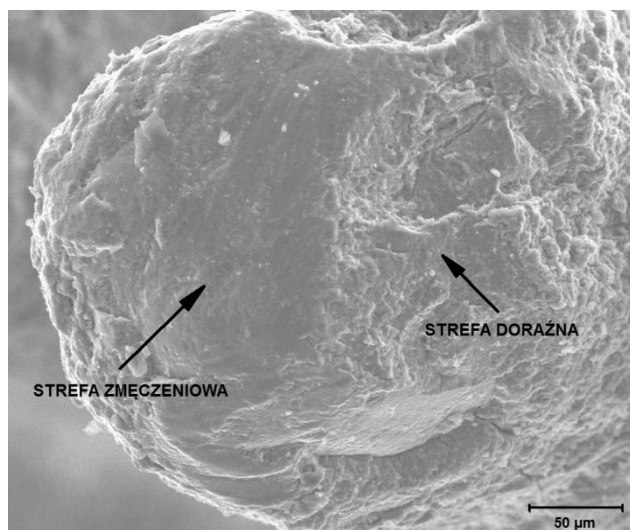
Rys. 2. Mikroskopowy obraz złomu zmęczeniowego pękniętego drutu pochodzącego z gąsienicy, pokazanej na rys. 1. Widoczna gładka strefa zmęczeniowa oraz strefa dorażna o rozbudowanej topografii powierzchni. SEM

Badania fraktograficzne drutów uszkodzonego stalowego kordu, wykonane przy użyciu skaningowego mikroskopu elektronowego, wykazały obecność powierzchni wskazujących na zmęczeniowy charakter uszkodzenia (rys.2). Część zmęczeniowa przełomu była gładka, z charakterystycznymi prążkami zmęczeniowymi układającymi się prawie równolegle do kierunku rozwoju pęknięcia. Ognisko przełomu zlokalizowane było na krawędzi zewnętrznej drutu, czyli w obszarze największego spiętrzenia złożonych naprężeń eksploatacyjnych. Na obwodzie zewnętrznym przełomów drutów widoczna była strefa doraźna o charakterze plastycznym i rozbudowanej topografii powierzchni. Wyniki tych analiz wykazały, zatem, że uszkodzenia nie powstało na skutek przeciążenia eksploatacyjnego gąsienic, ale w wyniku innych czynników skutkujących obniżeniem wytrzymałości zmęczeniowej drutów kordowych.

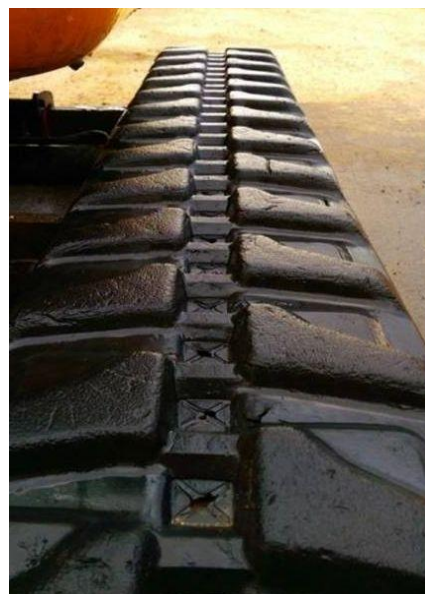
Rys. 7. Gąsienica elastomerowa Nr 2, próbka w stanie poeksploatacyjnym przez okres czasu wynoszący 1228 roboczogodzin. Na powierzchni widoczne liczne pęknięcia i uszkodzenia, krawędzie bieżnika znacznie zaokrąglone, a bieżnik porowaty.

Badania makroskopowe gąsienicy Nr 2, próbki w stanie poeksploatacyjnym wykazały, że nosi ona znaczne ślady zużycia wynikające z użytkowania maszyny. Na jej powierzchni roboczej zaobserwowano wiele zmian i uszkodzeń wynikających z bliskiego kontaktu z twardym podłożem

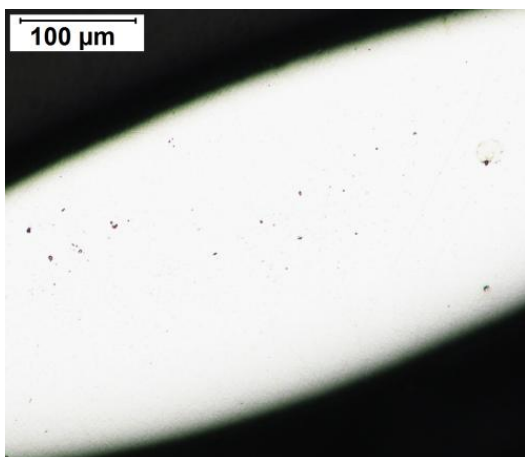
Rys. 8. Materiał drutu z kordu gąsienicy Nr 1, widoczne tlenkowe wtrącenia niemetaliczne w ilości równej wzorcowi 3 wg. PN-64/H-04510. Stan nietrawiony. Przekrój wzdłużny. LM

Obserwacje mikroskopowe materiału badanych drutów przeprowadzone w stanie nietrawionym wykazały obecność dużej ilości wtrąceń niemetalicznych, głównie w postaci tlenków. Zanieczyszczenia rozmieszczone były punktowo i występowały w ilości od wzorca 3 do 4 wg. EN 10247:2007, co według danych literaturowych [11, 16, 20] przekracza maksymalną dopuszczalną zawartość wtrąceń niemetalicznych w stali perlitycznej przeznaczonej do produkcji drutów kordowych (rys. 8 i 9). Wytrzymałość zmęczeniowa stalowych drutów jest w dużym stopniu uzależniona od czystości metalurgicznej materiału. Obecność tak dużej ilości wtrąceń niemetalicznych, szczególnie w postaci kruchych tlenków, może powodować obniżenie ciągliwości materiału utrudniając procesy technologiczne, a w szczególnych przypadkach prowadzić nawet do pęknięcia drutów w trakcie eksploatacji.

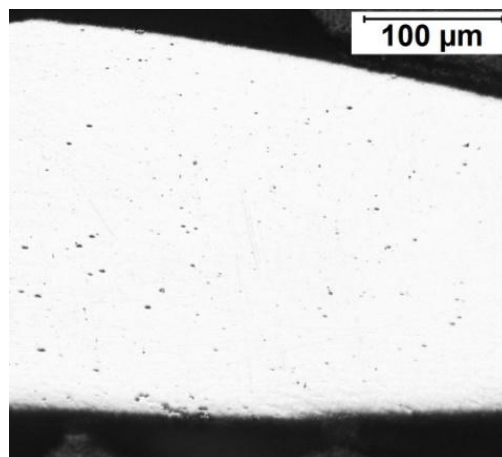
Rys. 9. Materiał drutu z kordu gąsienicy Nr 2, widoczne tlenkowe wtrącenia niemetaliczne w ilości równej wzorcowi 4 wg. PN-64/H-04510. Stan nietrawiony. Przekrój wzdłużny. LM

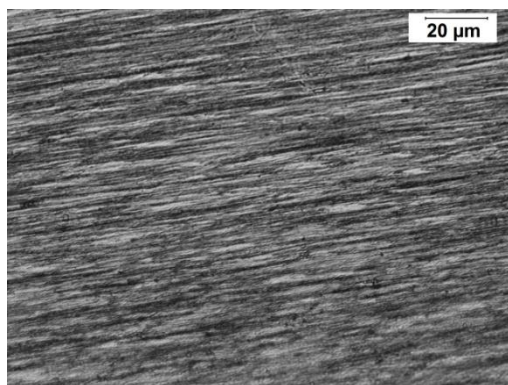
Rys. 10. Mikrostruktura próbki drutu, pochodzącego z kordu gąsienicy Nr 1, nowej. Widoczna silna tekstura zgniotu materiału wynosząca ok. 90%. Przekrój wzdłużny. LM

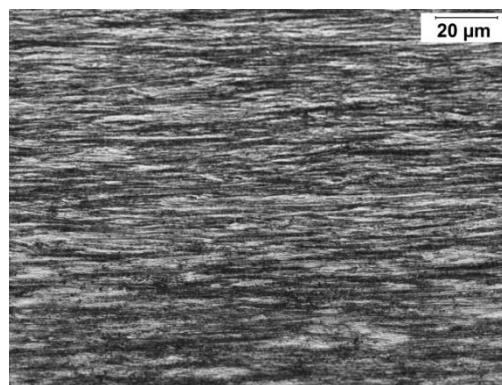
Rys. 11. Mikrostruktura próbki drutu pochodzącego z kordu gąsienicy Nr 2, eksploatowanej. Widoczna tekstura zgniotu materiału wynosząca ok. 80%. Przekrój wzdłużny. LM

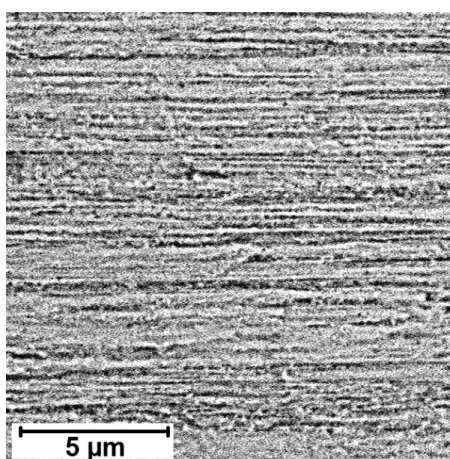
Rys. 12. Mikrostruktura próbki drutu pochodzącego z kordu gąsienicy Nr 1, nieeksploatowanej. Widoczna silna tekstura zgniotu materiału powstała skutkiem ciągnięcia na zimno. Przekrój wzdłużny. SEM

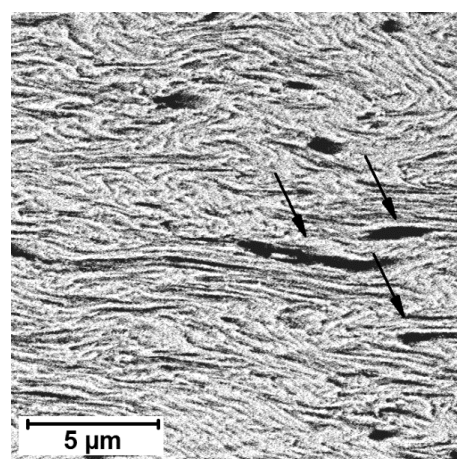
Rys. 13. Mikrostruktura próbki drutu pochodzącego z kordu gąsienicy Nr 2, eksploatowanej. Widoczne liczne nieciągłości materiału, powstałe w trakcie użytkowania gąsienicy (czarne strzałki). Przekrój wzdłużny. SEM

The microscopic tests have shown that all the tested wires, according to recommendations of the PN-EN 10323:2005 (U) standard, were made of the unalloyed pearlitic steel and the applied cold drawing process disabled achieving the high degree of plastic deformation of the 80–90% row (Fig. 10 and 11). The initial microscopic tests have not shown significant differences in the structure of the tested samples but further observations with application of the scanning electron microscopy have shown the clear influence of operating on structure of the tested material (Fig. 12 and 13). Results of the microstructure analysis have shown that during operation of the track chain the material of steel cord is destroyed. Presence of numerous structure discontinuities oriented in line with the plastic working of the material was observed caused by presence of non-metallic inclusions in the tested materials (Fig. 13).

Badania mikroskopowe wykazały, że wszystkie badane druty, zgodnie z zaleceniami normy PN-EN 10323:2005 (U), wykonane zostały z niestopowej stali perlitycznej, a zastosowany proces ciągnięcia na zimno umożliwił uzyskanie dużego stopnia odkształcenia plastycznego, rzędu 80–90% (rys. 10 i 11). Wstępne badania mikroskopowe nie wykazały znaczących różnic w strukturze badanych próbek, ale dalsze obserwacje, z zastosowaniem skaningowej mikroskopii elektronowej, uwidoczniły wyraźny wpływ eksploatacji na strukturę badanego materiału (rys. 12 i 13). Wyniki analizy mikrostruktury wykazały, iż w trakcie eksploatacji gąsienicy materiał stalowego kordu ulega niszczeniu. Zaobserwowano obecność licznych nieciągłości struktury zorientowanych zgodnie z kierunkiem przeróbki plastycznej materiału, przyczyną ich powstawania była obecność w badanych materiałach wtrąceń niemetalicznych (rys. 13).
