ARCHIVES
of
FOUNDRY ENGINEERING

Effect of Cathodic Protection on Corrosion of Water-pipe Network in Kraków - Case Study

The paper is a summary of a project aimed at identifying and eliminating or minimizing the causes of frequent failures of the Krakow water supply network related to corrosion damage. The paper presents the method of searching for factors responsible for frequent corrosion damage. There were taken into account several factors that may destroy the pipes associated with corrosion processes, such as the composition of the water, aggressiveness of ground, or stray currents. The monitoring method of the corrosion processes applied to observe the condition of the water supply network was discussed. The study showed that the main problem appeared to be stray currents related to the electrical infrastructure widely present in a large city, such as a tram or railway network. To eliminate this threat, a cathodic protection system has been implemented to prevent further failures. There were also demonstrated results of research proving that the applied solutions are effective.

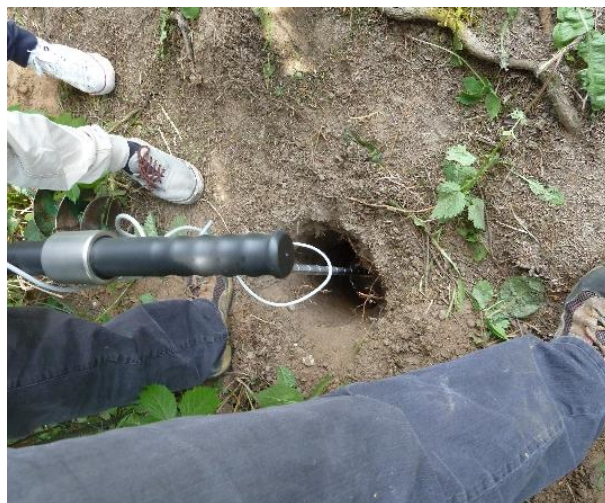
Fig. 2. Collecting the soil samples

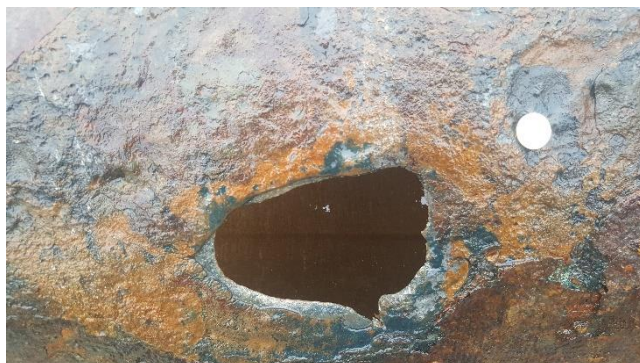
Most failures occurred at a site distant from the sources of stray currents sources namely the tramway and railway traction systems. For the Kościuszko Reservoir, despite the distance of about 1 km from the tram line, the impact of stray currents on the water supply system was visible. For the measurement point in Nowa Huta district, it was found that the water supply system was not endangered by the harmful effects of stray currents associated with the presence of tram traction or high voltage lines. For water supply bus at Wodna St. both the railway and tram lines occurred to be the source of the cathodic polarization of the pipe network in this area. Despite the significant distance from the tram and railway lines, the influence of stray currents was observed in the area of Hallera St. Figure 4 presents the effects of stray currents on water pipe corrosion.

Fig. 4. Corrosion damage of water pipe as a result of stray currents

To eliminate the influence of stray currents on the pipes transporting drinking water in the area of Krakow and to prevent metal corrosion as a result of electrochemical reactions with aggressive components of water and soil, the cathodic protection system was modernized and significantly expanded. In many places, interactions with other parts of the city infrastructure, such as gas lines, etc., which caused a short circuit with water pipes and initiated corrosion processes, were eliminated. The cathodic electrolytic protection system with an external DC electrical power source was used. By the end of 2020 in Krakow was installed 18 cathodic protection stations and 86 measuring points allowing control of potential in the pipeline.

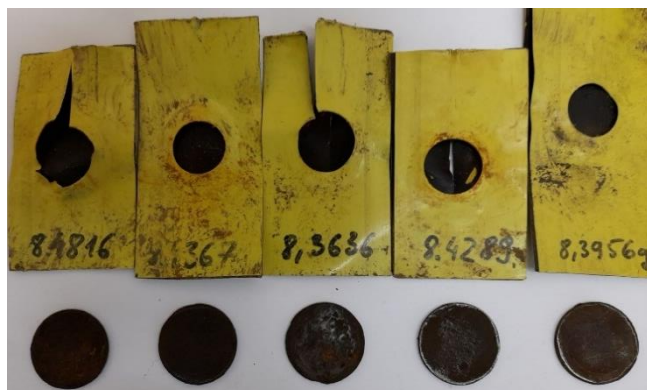
Samples of carbon steel with working area of 3.46 cm² were placed in soil for 4 years (June 2015 - May 2019) in the vicinity of the water reservoirs:

- Kościuszko Mound - 1 sample connected to the water pipe, no CP station in the area,
- Nowa Huta district - 1 sample connected to the water pipe, no CP station in the area,
- Wodna St. water bus supply - 1 sample connected with the water pipe, CP station at the distance of 10 meters,
- Hallera St. - 2 samples: 1st not connected to the pipe, no CP, 2nd connected to the pipe, CP station at the distance of 800 meters.

The samples after four years of exposure were cleaned according to the ASTM-G1 standard, etched in Clarke's solution and weighed. The corrosion rate was calculated based on the formula [19]:

Figure 5 presents samples taken out of the foil protecting non-corroding surface.

Fig. 5. Carbon steel samples after 4 years of exposure in the soil nearby to the main water tanks of Krakow water supply network

The lowest corrosion rate was recorded for the sample located in the immediate vicinity of the cathodic protection station. The highest corrosion rate was observed for the sample exposed in the Nowa Huta district, in highly corrosive soil (see Table 2) in the absence of cathodic protection. A very significant difference in the rate of corrosion was observed for two samples located at Hallera St. The value for the sample without any current protection is three times higher than that of a twin sample connected with a pipeline protected by a cathodic station almost one kilometer distant.

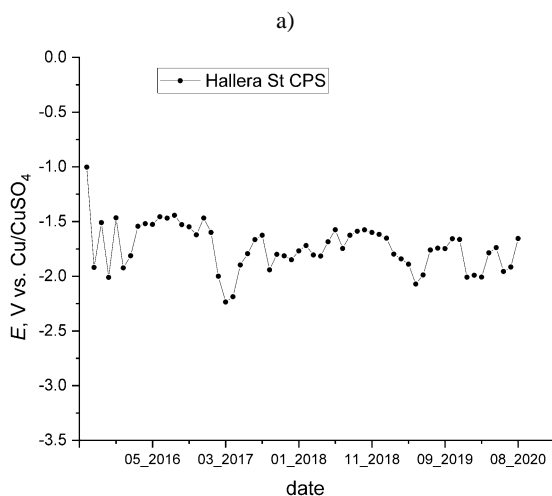
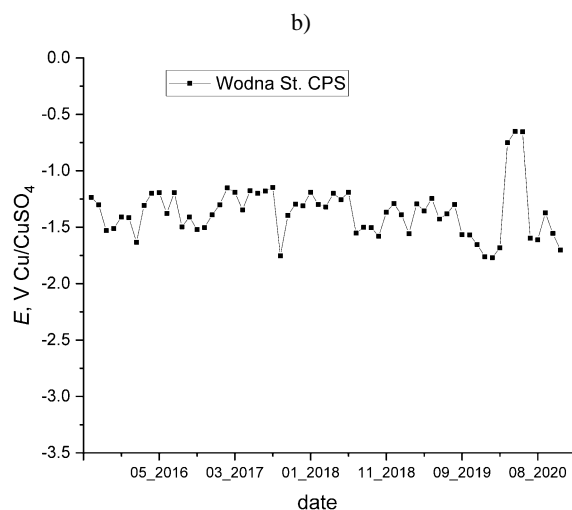
The current applied by the stations of the cathodic protection was set to maintain the value of the potential -850 mV vs. Cu/CuSO₄ electrode [13, 20-24]. Figures 6 a and b present the potential change of the water pipeline registered during 4 years period in CP stations at Hallera St. and water supply bus in Wodna St.

Fig. 6. Change in potential values of water pipes registered in cathodic protection station: (a) at the area of water tank in Hallera St., (b) in the vicinity of water supply bus at Wodna St.

The measured potential of the water pipe in the vicinity of the cathodic station in both cases indicates that the applied current density was sufficient to keep the pipeline potential at the desired level below -850 mV vs. Cu/CuSO₄.
