L. Van Parys¹, J. Noël², D. Lamblin³, S. Datoussaid⁴, A. Tilmant⁵

Disorders in north transept of the cathedral in Tournai (Be): Structural monitoring, simulations and temporary stabilization

Keywords: Heritage, Cathedral, Tournai, Masonry, Monitoring, Simulation, Stabilization

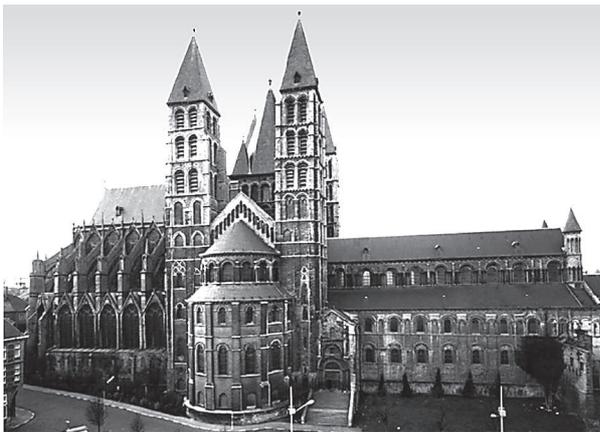
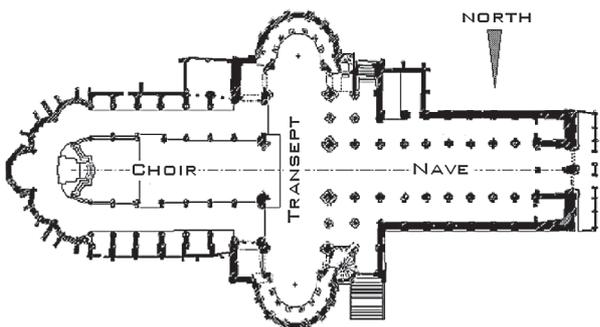
Fig. 1. North elevation of Our Lady cathedral (left) – plan view (right)

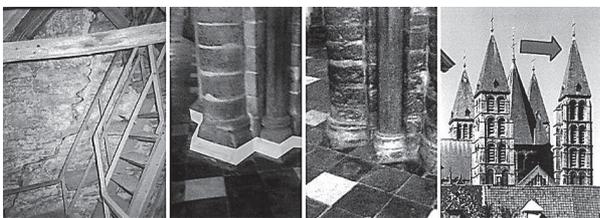
of the northern apse path as well as the walls of the major stairway located inside the Brunin bell tower are clearly concerned. Areas that are not accessible to the visitors definitely confirm the trend: wide opened cracks affect the impressive

Fig. 2. Crack in wall upside vaults (left) – pillar settlement (centre) – global inclination (right)

masonry walls supporting the roof system upside the vaults. The **differential settlements** represent a second family of signs. They affect portions of walls as well as particular pillars with sensible amplitude. They can easily be detected by respectively considering horizontally built stone bands (some of them are clearly inclined) or the vertical position of sculpted pillar basements relatively to the stone floor level that has been replaced some times during the 12th and 13th century and is then rather flat and horizontal (some of them are almost 10 cm embedded in the pavement). The **global system deformations** constitute a third family of signs. Hardly noticed through a local focus, they definitely appear as soon as a concerned system may be considered globally. Walking from the railway station, the severe inclination of the Brunin bell tower towards the west (80 cm at the top of the tower) visually appears in proximity with the four other bell towers. Through these signs, the cathedral clearly expresses the existence of pathologies implying its structure.

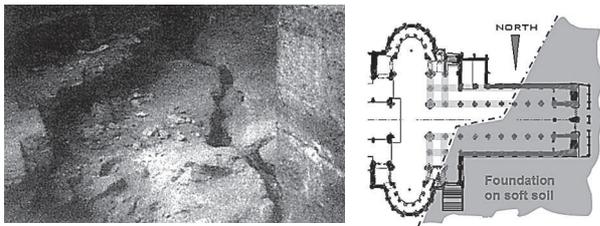
Fig. 3. Crack in foundation walls under pavement (left) – synthesis of collected information (right)

ments allowed establishing a 3D model of the underground stratification in the cathedral area: the layer of soil interposed between the top of the carbonate bedrock and the bottom of the foundation system reveals thicknesses varying from 0 up to 6 meters, sometimes abruptly (about 5 meters of vertical delta on less than 3 meters of horizontal delta) and the quality of this soil appears to be globally poor.

These works were carefully carried out by a team of archaeologists under the direction of Professor BRULET (Université Catholique de Louvain – BE). They revealed precious information [3] bringing to light some historical elements of the birth and life of the building. The remains of the previous constructions were partly unearth and the works allowed recognizing the morphology, pattern and levels of the actual foundation system that is composed of impressive and continuous stone masonry walls (external leaves and mixed filling), homogeneously dispatched under external walls and internal pillar rows. In parallel to this information, the manual excavations also allowed confirming the clear continuity of each severe crack affecting the upper parts of the building throughout the foundation, leading to the total disconnection of elements in some places. In this framework, the continuous foundation system designed by the medieval builder for ensuring the stability of the Romanesque structure now appears to act as a set of independent blocks, namely in the problematic zone surrounding the Brunin bell tower. Continuing the manual digging action down to the basis of the foundations made it possible to observe the nature of the material on which the foundation is posed: soft soil in some places or carbonate bedrock in others.

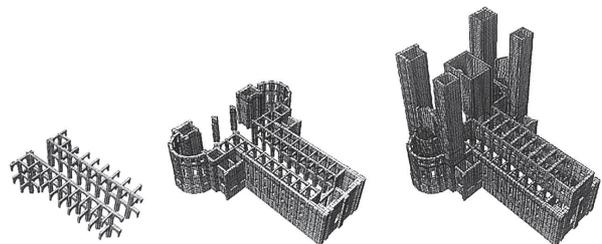
The soft soil layers interposed between the top of bedrock and the bottom of the masonry foundations has been carefully modelled as it definitely drives load redistribution in our statically redundant structure. In practice, a preliminary approach

Fig. 4. Erection of the simplified FE model for the transept and nave system

with Winkler approximations¹ appeared to be insufficient as it was not likely to effectively capture the pressure bulb development and its potential effects. Then, the effective presence of soil material has been privileged, a simplified constitutive model being chosen as only the impact of deformations on the masonry system was interesting to be replicated. The bottom face of the soft soil is constrained for simulating the effect of the subsequent bedrock. Lateral earth pressure acting on each underground masonry foundation walls have been computed in the Lower Limit State according and applied as equivalent surface loads on the model.

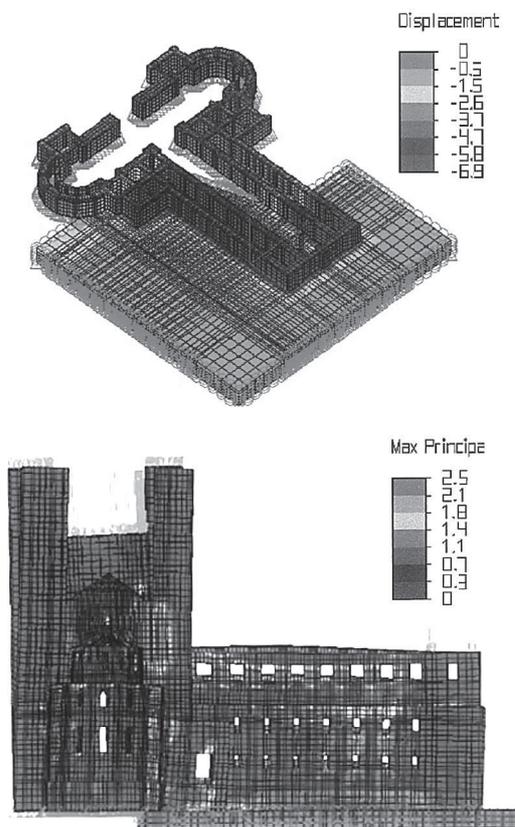
A routine developed by J. NOËL and improved by J. COUVREUR likely to automatically manage the evolution of cracking process in the models through nodes duplications [7] allowed to precisely follow the crack propagation inside the global system. It clearly appeared that the more the cracks progresses in the gable wall, the arch and the apse, the more the bell tower get inclines itself [8, 9]. The proposed simplified FE approach gives good clues concerning the causes for most of the pathologies concerning the north gable wall, the north apse of the transept and the inclination of the Brunin bell tower. Indeed, the presence of an important gradient in soil quality under the Brunin bell tower could explain some of the pathologies highlighted in the models and visible *in situ*. Three corners of the Brunin bell tower are posed on a thick layer of bad quality soft soil although the last one is directly posed on the bedrock. The massive stone structure of the bell tower makes an eventual settlement of soil layers to be significant.

Fig. 5. Settlement for foundation and soil model (left) – tensile stressed zones in the system (right)

A modelling of the first steps of the construction of the cathedral revealed that already shortly after their building, the foundations would have been submitted to excessive traction in the area of the good/poor quality soils transition line [7]. In this way, the superstructure of the cathedral seems to have been

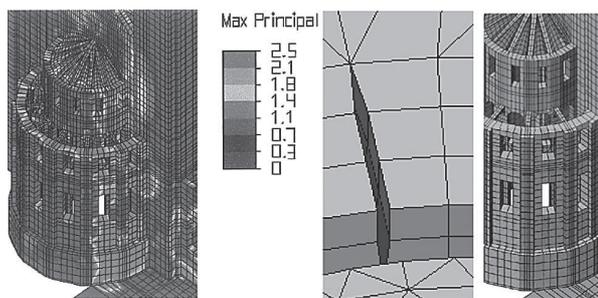
Fig. 6. Tensile stresses around Brunin bell tower (left) – node duplication & concerned zones (right)

The differential effect induced by the heterogeneous posing conditions brings the occurrence of parasite sollicitation inside the system (bending, tension, shearing) that induce the development of disconnections, opening the way to still important inclination motions.

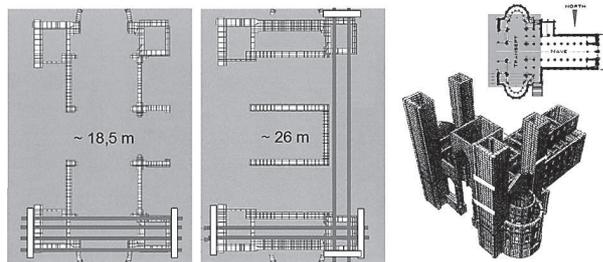
Fig. 7. urgency stabilization system with post-stressed steel bars designed with FE models

Designing an urgency stabilization structure for a cathedral submitted to significant soil motions is not usual and then not particularly easy. To become installed on a complex site, it has to be ingenious. The proposed solution relies on post-stressed steel bars for temporarily anchoring the Brunin bell tower inside undamaged bells tower along both the east-west and the north-south direction. For making the system to be efficient, the convenient localization of bars should be achieved as well as the choice of a suitable section and repartition system for avoiding potential failure occurring in the steel system or in the still undamaged masonry parts. The effective design and the related impact study has been carried out with FE models derived from the one presented previously. A 10mm settlement increase under the Brunin tower has been introduced in the cracked model and the efficiency of steel bars has been analysed. It gave birth to the solution that has been effectively: 2 bars × 50 mm bars placed at level 25,5 m from pavement

with 6500 daN post-stressing each in the east-west direction, 4 bars \times 50 mm bars placed at level 18,5 m combined with 4 bars \times 50 mm bars placed at level 26,5 m with 5000 daN post-stressing each in the east-west direction. According to the FE studies, the chosen configuration of stabilization (position, number and post-stressing force) is likely to reduce the crack openings induced in gable walls by any further settlement for more than 60%.
