## **Operational Problems of Selected Elements of the Dobrzyca Barrage on the Głomia River**

*Mateusz Hämmerring, Natalia Walczak,  
Tomasz Kałuża, Anna Oliskiewicz-Krzywicka  
Poznan University of Life Sciences*

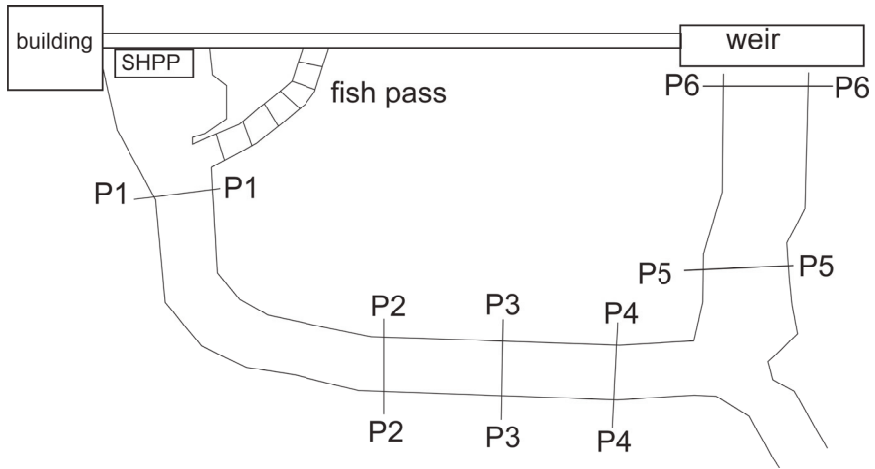
The aim of the study was to technically assess a condition of particular elements of the barrage (Fig. 1 – weir, fish pass and power plant) and to analyse its operation under specific hydrological conditions. The main element of the Dobrzyca barrage is a three-gate movable weir. Figure 1 shows a schematic diagram of the structure.

**Fig. 1.** Sketch of barrage elements with spacing cross section

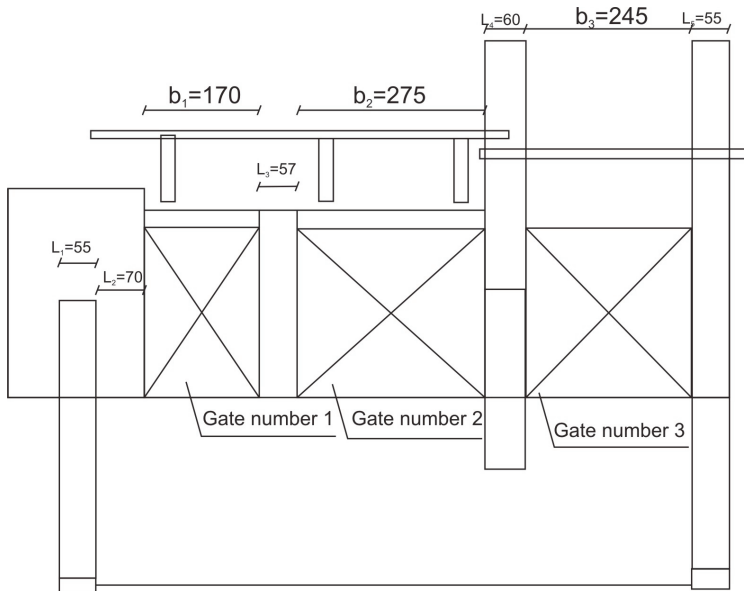
The weir on the Głomia river belongs to the group of movable weirs (Fig. 2 and 3). The structure has three gates of  $b_1 = 1.7$  m,  $b_2 = 2.75$  m,  $b_3 = 2.45$  m respectively, and two piers of 0.57 m and 0.60 m. The weir is equipped with flat shutters – stop logs used for constant impoundment of water. There is an abutment of 0.55 m width located on the right side/bank of the weir at a distance of 0.7 m from the gate no 1. The standard impoundment level of the barrage is 64 m a.s.l.

**Fig 3.** Weir draft, Dobrzyca barrage on the Głomia river (dimension in cm)

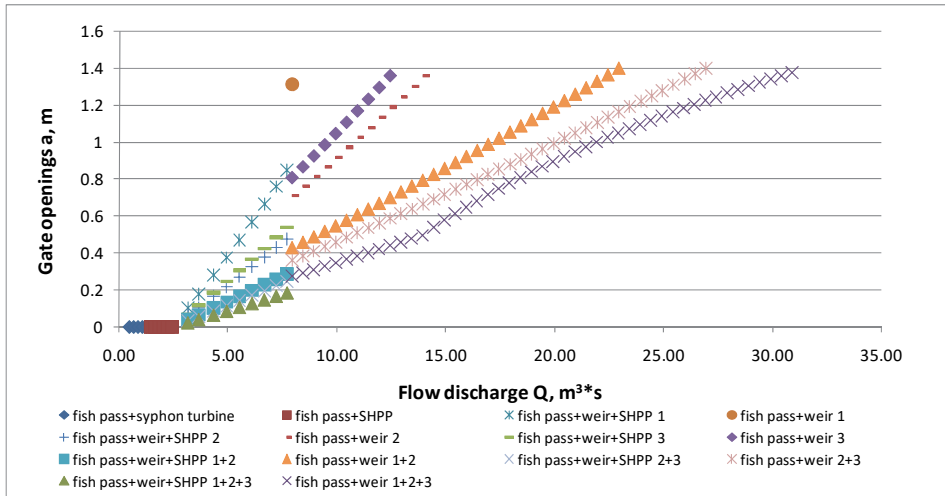
Figure 6 presents the operational scenario for the node assuming the operation of all openings of the weir. In the initial stage the fish pass and SHPP operate, following an increase in the flow rate all three shutters are being opened simultaneously. By opening up all gates, the impoundment structure significantly increases its capacity. Figure 7 shows how different water levels of the downstream affect the operational curve of the node for flow rates higher than  $14 \text{ m}^3 \cdot \text{s}^{-1}$ . Summing up the flow rate of the weir and the fish pass, the barrage can transfer  $30.95 \text{ m}^3 \cdot \text{s}^{-1}$  of water. With regard to the design flow rate, that is  $20 \text{ m}^3 \cdot \text{s}^{-1}$ , the total capacity of the barrage is sufficient.

**Fig. 6.** Barrage operation curve with opening all gates and SHPP in Dobrzyca barrage on the Głomia river

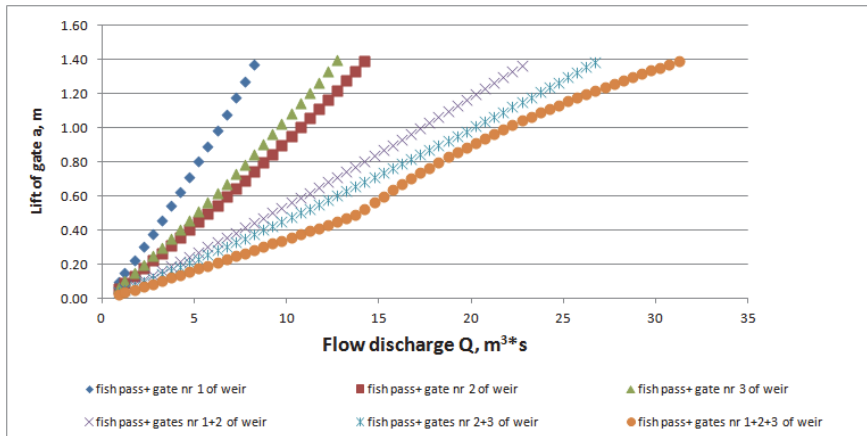
**Fig. 7.** Barrage operation curve at switch off SHPP
