## Evaluation of Modern Diesel Engine Fuel Injectors

Tomasz Osipowicz, Sebastian Kowalek

Experimental research concerned diagnose of electromagnetic Bosch Common Rail injector with catalog number 0445110083. The aim of researches was to make correct diagnose and eventually regeneration process of the researched injector. Researches were made by using special instruments and testing machines in a laboratory research unit and then repairing injection systems of combustion engines.

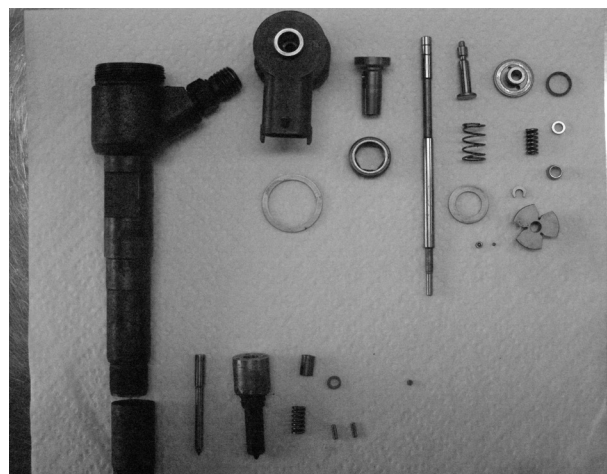
The research object was Common Rail electromagnetic Bosch injector generation 1.0 with catalog number 0445110083. Picture 2 shows the disassemble of the injector into spare parts.

**Fig. 2.** Electromagnetic Bosch generation 1.0 injector disassembled into spare parts
