Breńkacz Ł., Bagiński P., Adamowicz M., Giziewski S. Failure analysis of a high-speed induction machine driven by a SiC-inverter and operating on a common shaft with a high-speed generator. *Eksploracja i Niezawodność – Maintenance and Reliability* 2022; 24 (1): 177–185, <http://doi.org/10.17531/ein.2022.1.20>.

## Failure analysis of a high-speed induction machine driven by a SiC-inverter and operating on a common shaft with a high-speed generator

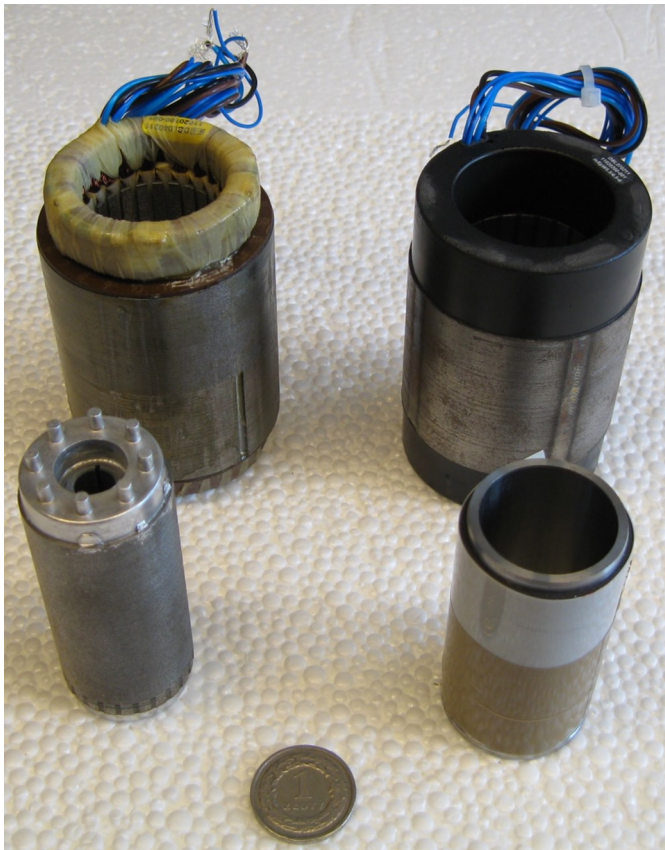
Fig. 1. Stator and rotor of a 3.4 kW induction motor/generator (left) and a 6-kW permanent magnet synchronous motor/generator (right) designed to operate at speeds above 80,000 rpm and voltage frequency above 1.3 kHz.

trol algorithms at high rotational speeds [12, 33]. The development of these technologies affects both high-speed induction motors/generators that are valued in the industry for their reliability, simple rotor design, low inertia, and ability to operate in high temperatures, as well high-speed permanent magnet motors/generators with high torque density and power density. The stator and rotor of a 3.4 kW generator and a 6-kW generator, which were used on the test rig analysed, are shown in Fig. 1.

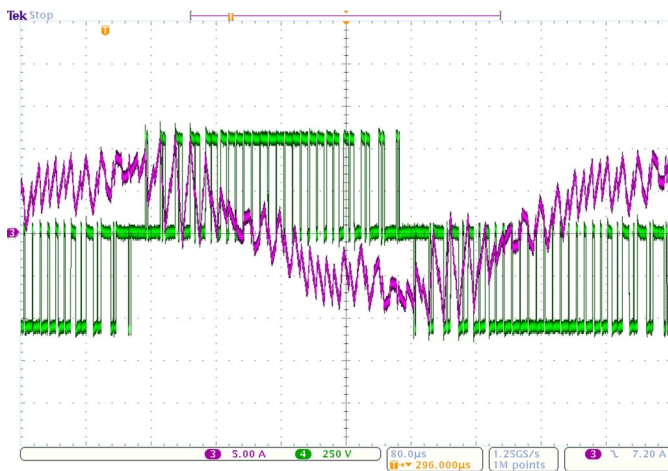
Fig. 6. Voltage and current waveforms of the stator of a 3.4 kW induction motor installed in the tested system with a silicon carbide inverter at voltage frequency of 1.5 kHz measured before the sinusoidal filter

Fig. 6 shows the current and voltage oscillogram obtained at the output of the inverter. The high-frequency ripple currents visible on the current waveform have very high values (like the amplitude of the fundamental harmonic of the current) due to the very low inductance (about several millihenries) of the stator winding. Fig. 7 shows the current and voltage oscillogram obtained at the output of the sinusoidal filter in the tested system with a silicon carbide inverter.

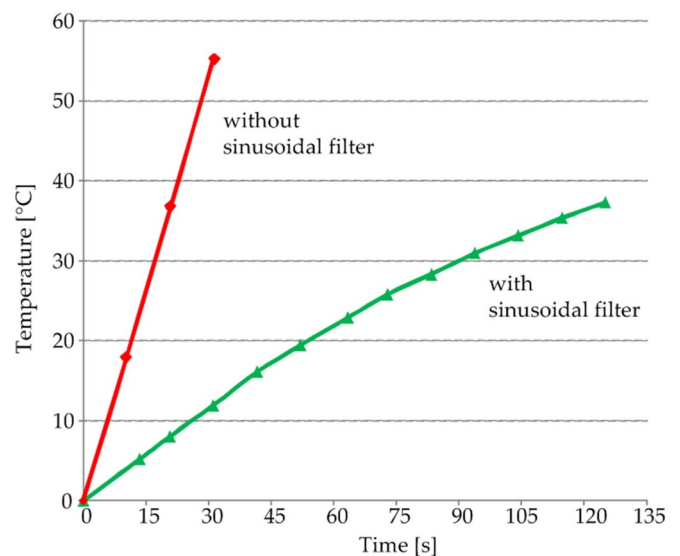
Fig. 8. Temperature increments of the stator of a 3.4 kW high-speed induction motor powered by a SiC inverter with and without a sinusoidal filter

Fig. 8 shows a comparison of the temperature increments of the stator of a 3.4 kW high-speed induction motor. The tests were performed at a motor load of 70% with the power supply at a voltage frequency of 1 kHz. Temperature measurements were carried out by measuring the resistance of a  $4.7 \text{ k}\Omega$  negative temperature coefficient (NTC) thermistor mounted in the bearing disk of the high-speed induction motor. As shown in Fig. 8, the absence of a sinusoidal filter at the output of the inverter leads to an abrupt and very large increase in the temperature of the stator due to thermal losses caused by eddy currents and hysteresis losses in the stator core. The use of the LC

sinusoidal filter results in a significant reduction of thermal losses and allows the high-speed motor to run for a long time.

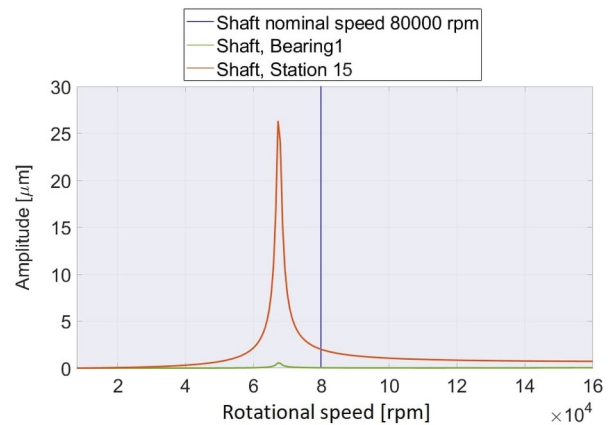
To check whether the unbalance can induce natural vibration of the structure, a harmonic analysis must be performed. The results of the forced vibration analysis are shown in Fig. 17. The green line on the graph represents the vibration amplitude of the journal of the first bearing as a function of speed from 0 to 160,000 rpm. The red line, on the other hand, represents the vibration amplitude of node No. 15 in the central part of the rotor. This is the last node of the first generator and thus the part of the rotor that is most vulnerable to abrasion. For

design reasons, the distance between the rotor and the stator in this area, measured radially, is only 300 μm. In the numerical model, the global damping was assumed to be 1%. The blue vertical line indicates the nominal rotational speed. The maximum vibration amplitude occurred at a speed of 67,277 rpm and was 0.56 μm at the bearing journal and 26.33 μm at the central part of the rotor.

Fig. 17. Forced vibration analysis

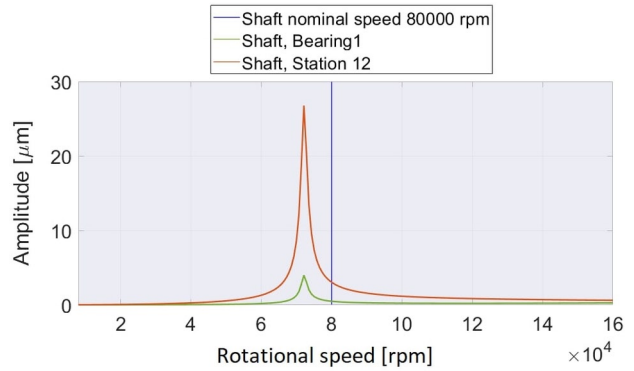
The forced vibration analysis shows (Fig. 19) that the maximum displacement of the bearing journal (node 5 – green line) and of the part of the rotor which is most exposed to stator rubbing (node 12 – red line) was respectively 3.97  $\mu\text{m}$  and 26.76  $\mu\text{m}$  at a speed of 72,130 rpm. Compared to the reference case, the vibration amplitude has hardly changed. What has changed is the speed at which the resonant vibration occurred; it changed by 4,853 rpm. This indicates an increase in the maximum permissible speed of almost 5,000 rpm. However, for safety reasons, a speed of 6,000 rpm should not be exceeded.

Fig. 19. Forced vibration analysis
